# COLOUR, FORM AND SPACE

RIETVELD  
SCHRÖDER  
HOUSE  
CHALLENGING  
THE FUTURE

Marie-Thérèse van Thoor [ed.]

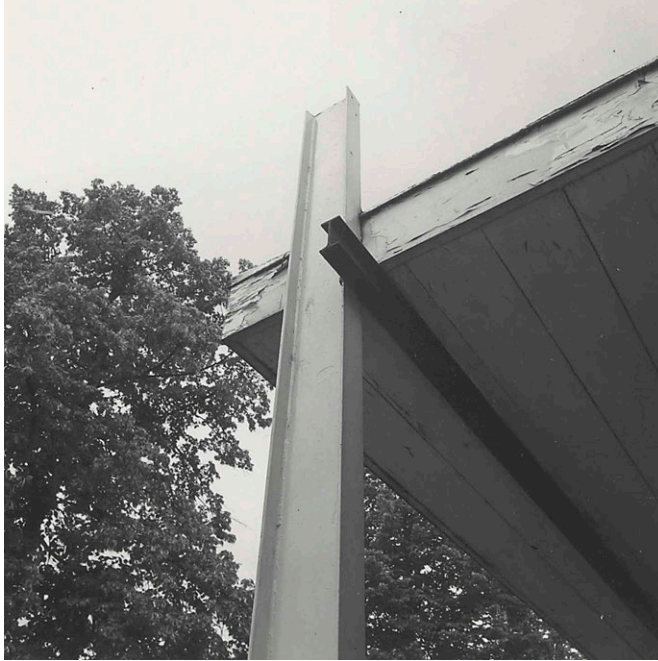
FIG. 1.4 Unconventional constructions made the house vulnerable

This was mainly because Rietveld considered the spatial effect and associated appearance, and the optical effect, more important than a stable and sound construction [FIG. 1.4]. This had resulted in unusual combinations of traditional and modern materials (and their properties) and techniques which, after the passage of so many years had started to exhibit all manner of defects. For example, the way the steel beams had been tailed into the (single-skin) brickwork had led, through the action of moisture, to rust and hence to cracks in both brickwork and plaster. At Rietveld's insistence, the concrete slabs used for the balconies had to be very thin so that here, too, moisture had been able to corrode the steel edges, which had started to rust, and the concrete had begun to display cracks [FIG. 1.5].

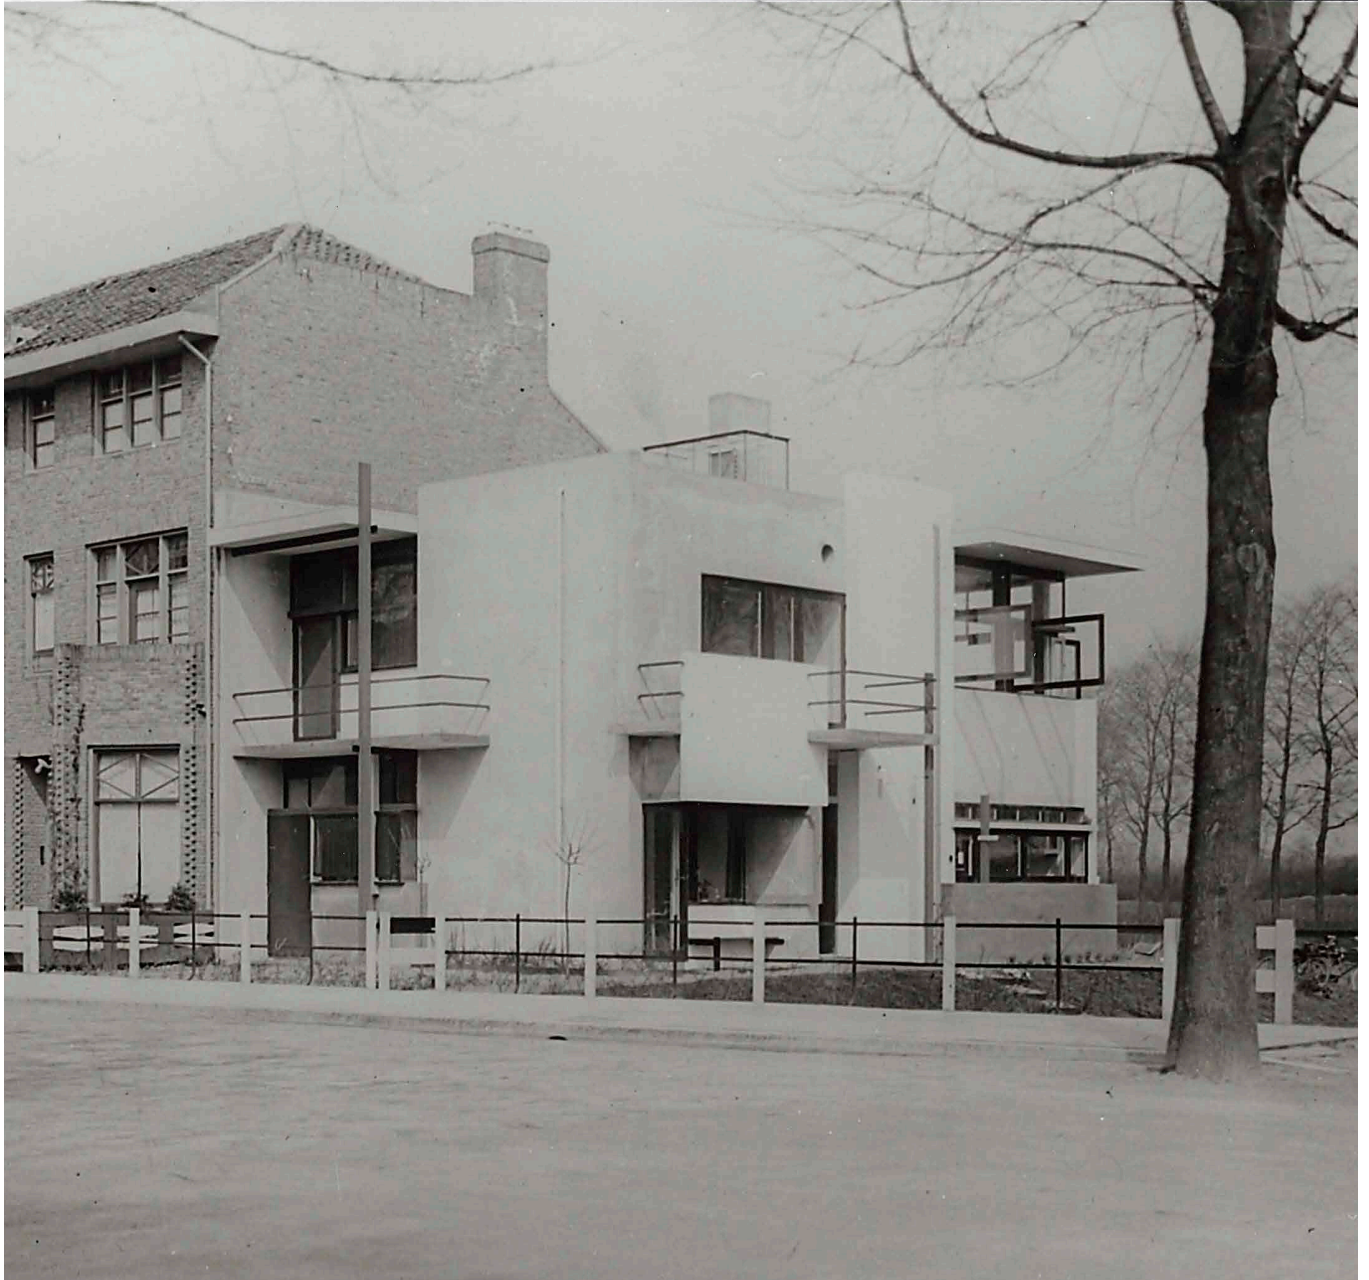
FIG. 2.1 One of the earliest photographs of the Schröder House, c. 1925

In the very first photographs taken directly or not long after construction, it is possible to see that various wall surfaces, as Truus Schröder had recalled, look very spotty [FIG. 2.1]. Apart from the spots, the photographs reveal that the walls were painted in white and shades of grey. But these images do not allow the number of greys to be ascertained – maybe four, maybe five. Looking at the photos from the next decade, there appear to be differences in the composition of the white and grey values of the various surfaces, but it may simply be a case of differences in nuance.

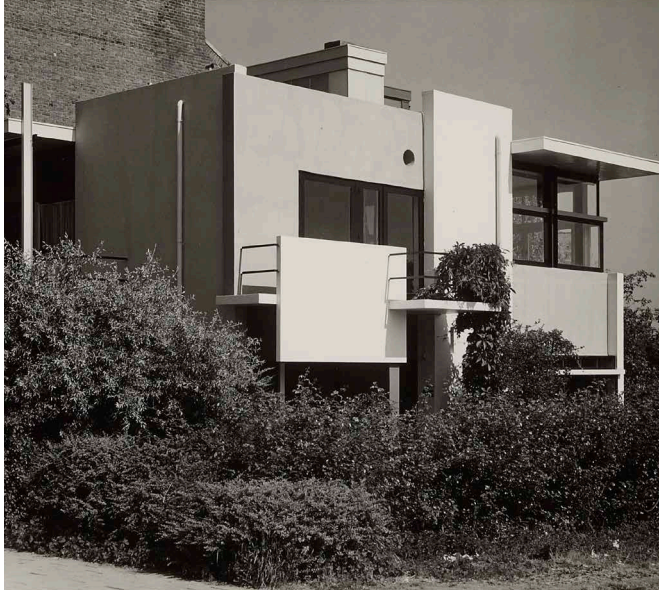
FIG. 2.4 In the 1940s or '50s the house was increasingly hidden behind greenery

In the photographs taken in the period between the 1930s and 1960s, the house is increasingly hidden behind the foliage [FIG. 2.3/2.4]. This not only gives it a completely different presence than before, but the greenery also affects how the white and grey

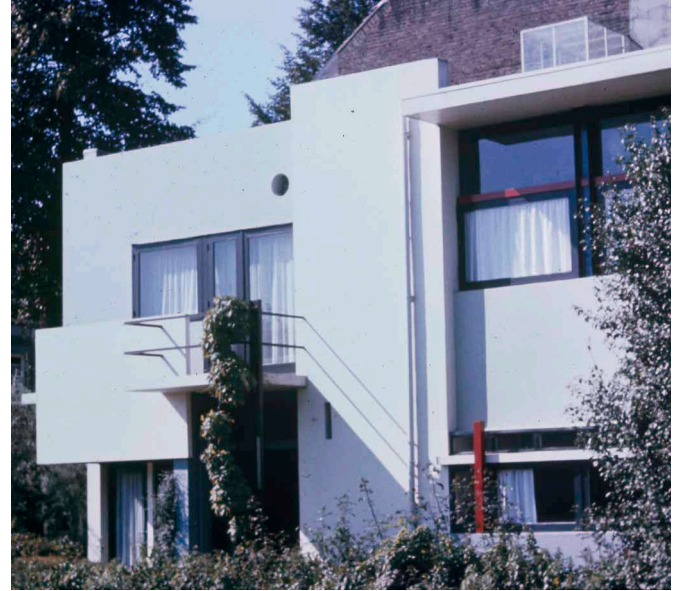
FIG. 2.5 A colour photograph from before the restoration shows that the greys had become bluish

Most of the photographs dating from the early 1970s show the damage and poor state of repair – or perhaps the mediocre outcome of the Van Poppel paintwork – of the Schröder House. The contrasts between the greys are barely discernible, even in the colour photographs. According to Mulder, the greys from the period before the restoration were bluish as well, because back then the greys were only mixed with black [FIG. 2.5].<sup>11</sup>

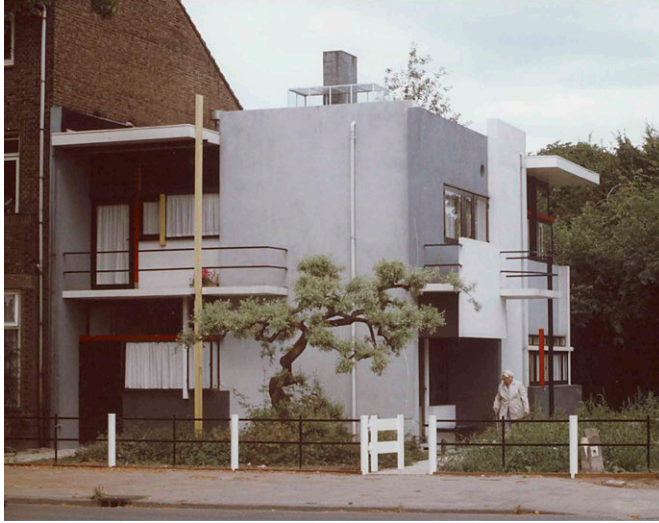
FIG. 2.6 The house in the early 1980s, after the second treatment of the exterior

than ever to find enough walls and elements on the exterior of the Rietveld Schröder House with traces of original layers of paint that would allow the overall colour palette of the house in 'the most original state' to be pieced together [FIG. 2.6].

blue. Mrs Schröder recalled that when she first met Rietveld, many people considered black obtrusive, but according to Rietveld black actually receded into the background. He used it for elements – like door and window frames – that were not intended to obtrude, with the result that everything appears to be in the same plane and the composition is emphasized [FIG. 2.6/2.10].<sup>25</sup>

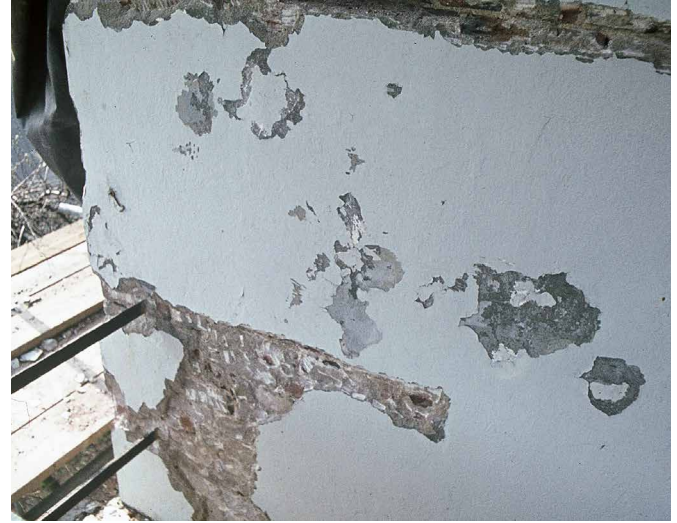
FIG. 2.7 In various places, such as the chimney, B. Mulder found still more finish coats and colours that he could include in his colour research

Upon inquiry Mulder turned out to have yet more information in the form of a series of slides and a set of colour samples.<sup>20</sup> Detail photos of the chimney show various finish coats and it appears possible to distinguish several colours. Even more interesting is a photo of the wall below the kitchen window in the east elevation [FIG. 2.9]. We can see various shades of grey, from light to dark, and between them the white of a base coat. Mulder's caption reads: 'I opted for a dark grey from top right corner.'<sup>21</sup> This is one of the wall surfaces that were not repaired and on which the original plaster is still present, according to Mulder. Nevertheless, we are left guessing about the dates of these grey coats because there is simply no further documentation and also because references to other wall surfaces are lacking. The layers of paint on the walls, which were entirely stripped in 1979, were removed together with the old layers of render.

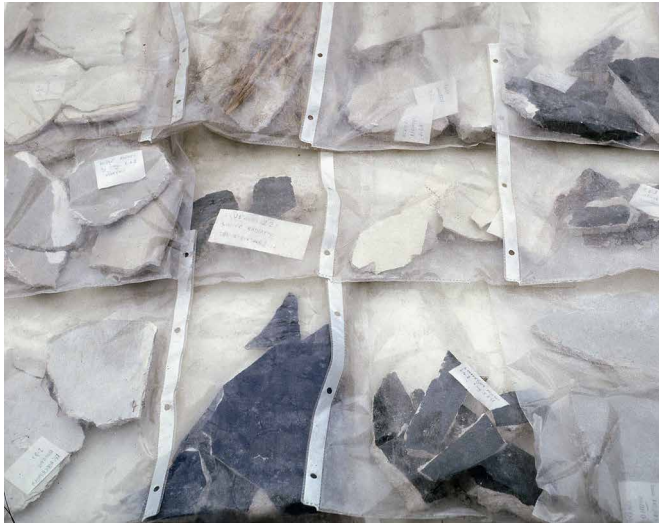
FIG. 2.8 Plaster and colour samples packed in plastic bags

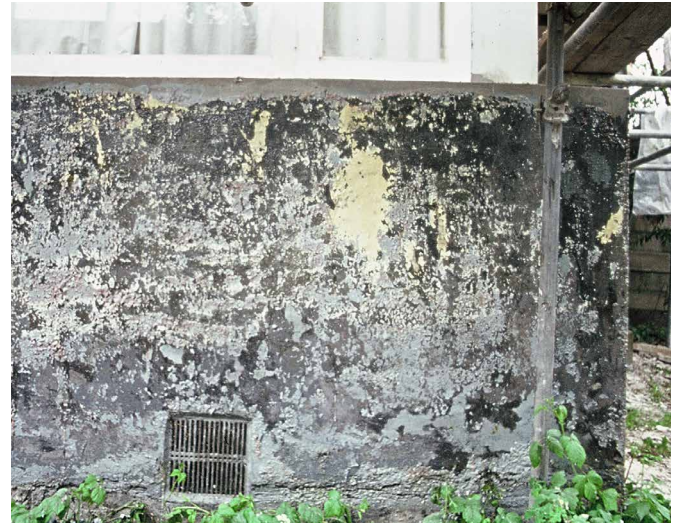
FIG. 2.9 Wall below the kitchen window in the east elevation; B. Mulder chose the dark grey of the top right corner for the new colour scheme

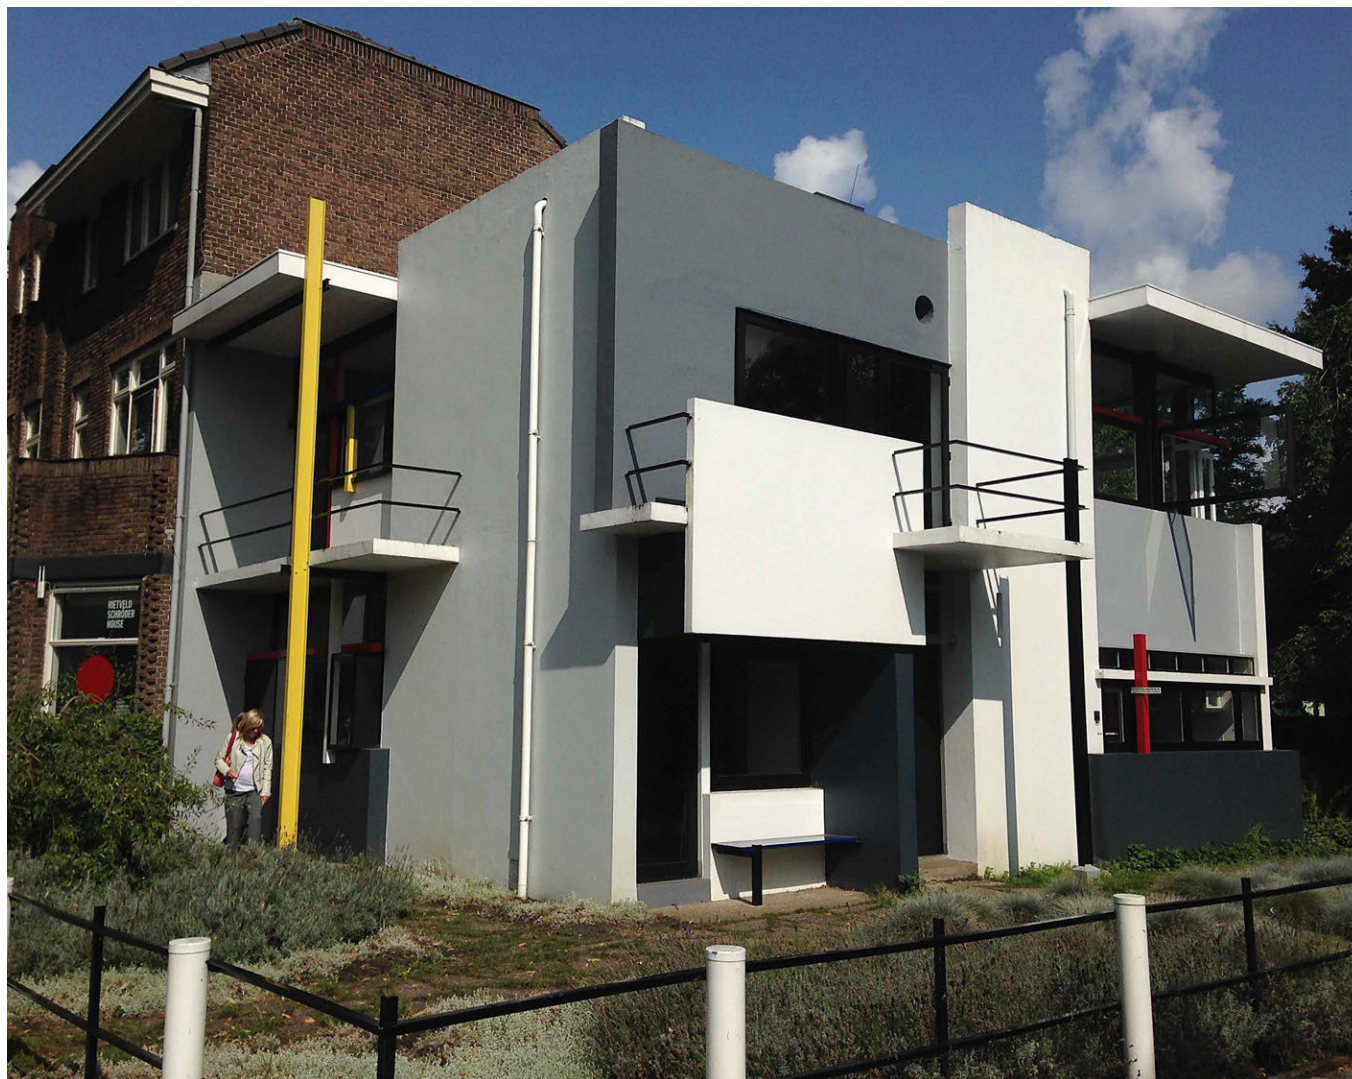
FIG. 2.10 The Rietveld Schröder House in 2017

Currently, the walls display not three, four or six, but five shades of grey, because that is what Mulder says he found during his on-site inspection [FIG. 2.10]. In consultation with the foundation he opted to return to the colour composition of the initial period. With that frame of reference, which involved mixing the greys on site with the painter, he made a composition with five greys (photo on page 22). For the record, Mulder said that making the different shades of grey was the most difficult part of the entire restoration and occasionally even drove him ‘to despair’.<sup>26</sup>

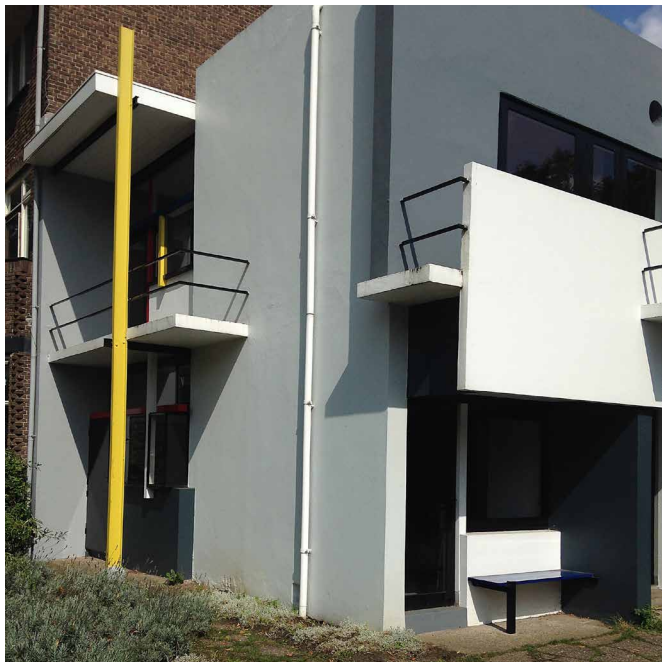
FIG. 2.11 Prins Hendriklaan wall, white rainwater pipe against pale grey background, 2017

The various rainwater pipes were eventually treated in different ways. We can see both white against a pale grey surface (large wall Prins Hendriklaan) [FIG. 2.11] and pale grey against a white surface (to the right of the front door) [FIG. 2.12]. The pipe on the rear elevation is white against a white wall, and that next to the neighbouring building at Prins Hendriklaan 48 is pale grey against an identical pale grey background. This does not appear to be in accordance with the earliest period of the house. In photographs, especially those taken straight after the construction, the rainwater pipes are a natural zinc-grey in colour. But Mulder did regard the drainpipes and their colours as important elements of the overall composition. In an interview with *Cobouw magazine* in November 1974, a few months after the letter from Han, he raised the question of the rainwater pipes himself, in particular the white-painted downpipe on the ‘side elevation’, against the grey background. This downpipe had been absent for a while, was then painted in a zinc colour, and thereafter ‘painted white as [was] intended against the grey background’.<sup>30</sup> Thus, even the colours of the rainwater pipes could completely alter the character of the walls.

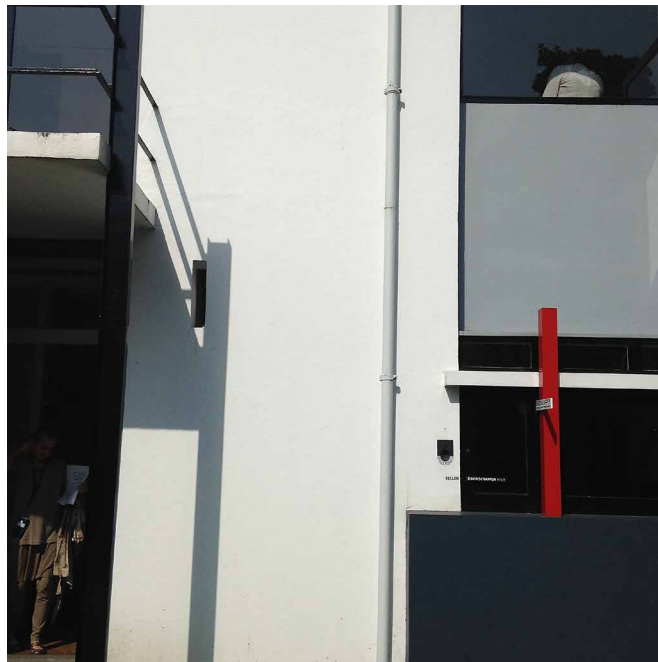
FIG. 2.12 East wall beside front door, pale grey rainwater pipe against white background, 2017

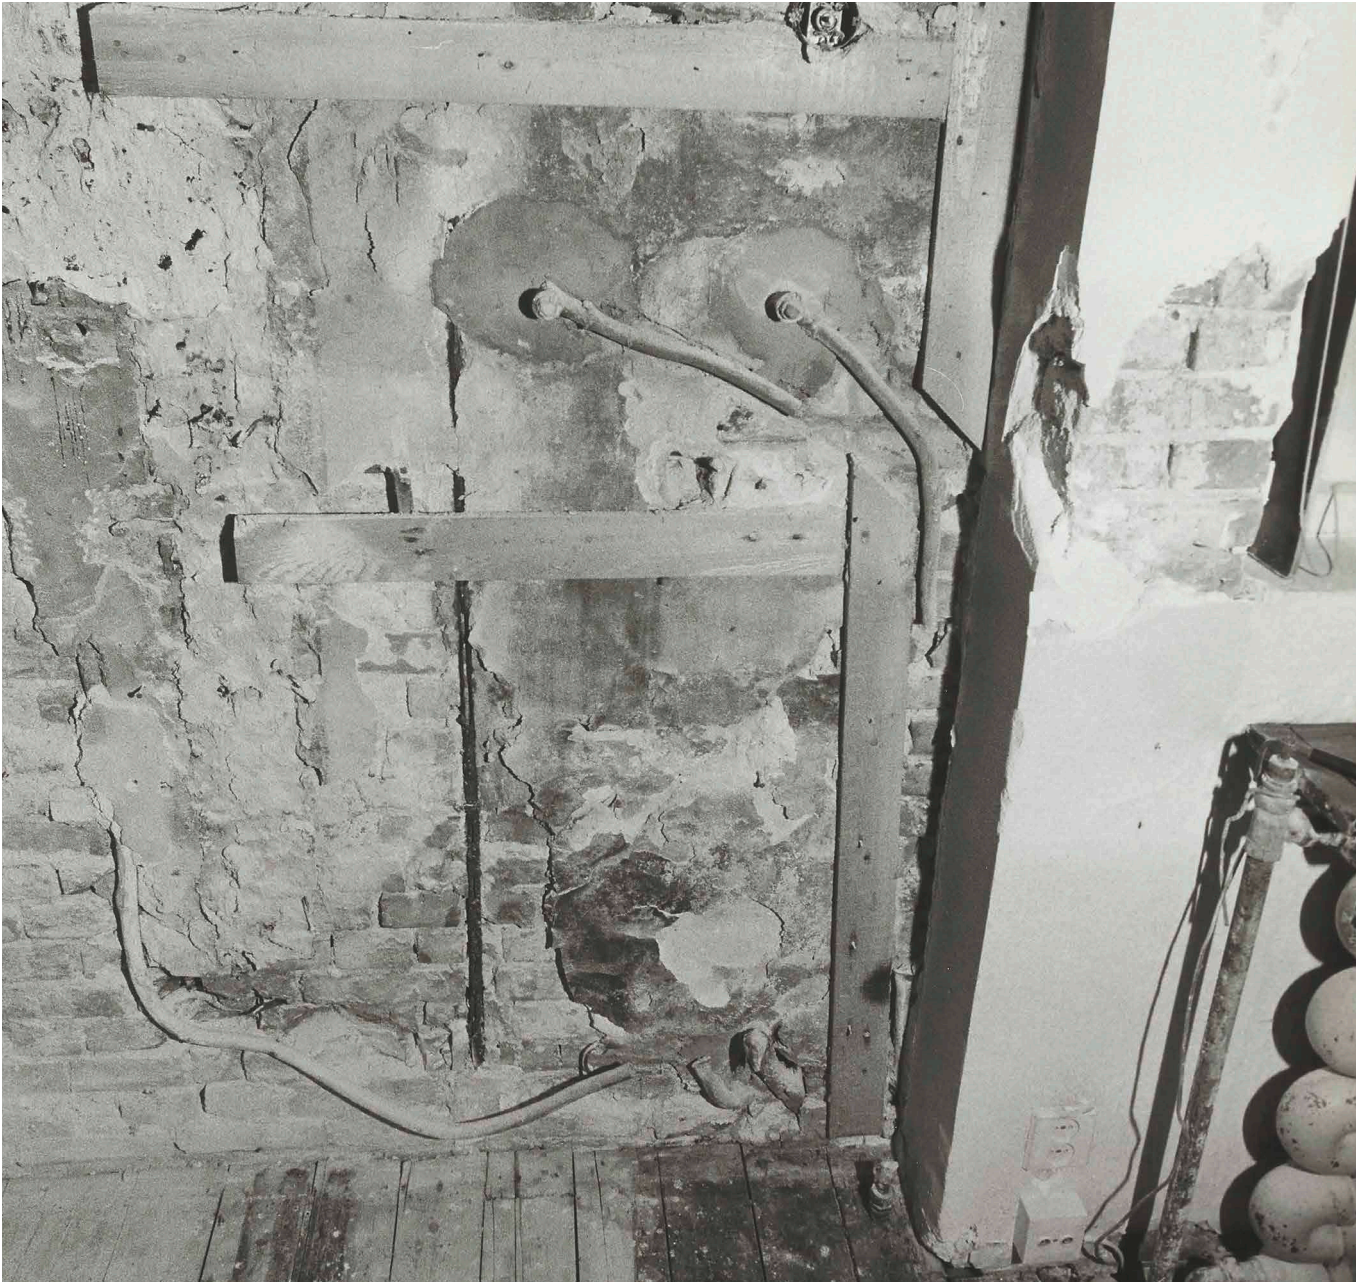
FIG. 3.1 The dismantling of wall, floors and ceiling yielded a lot of information about pipes, connection points and the attachment of furniture

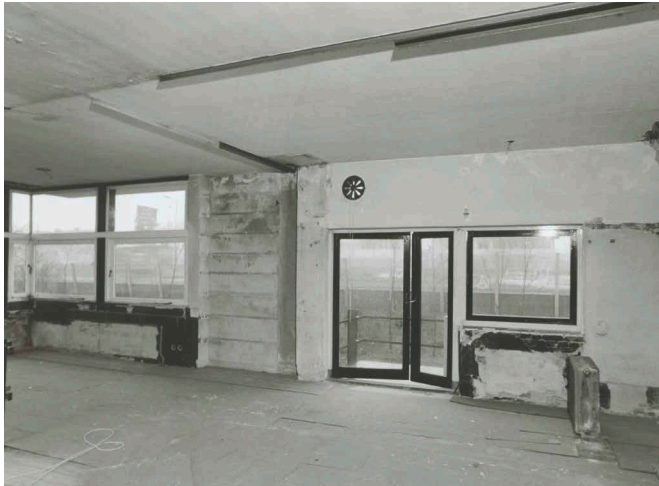
FIG. 3.3 The partially dismantled upper floor

The most visible and radical aspect of the restoration of the upper floor was the stripping of the walls and ceiling, the elements that were so crucial to the spatial picture [FIG. 3.3/3.4]. Stripped back they revealed only 'bare brickwork' and a bare soffit [FIG. 3.5/3.6/3.7]. 'The [foundation] and I were of the opinion that we would only be able to make the original spatial picture clearly and definitely tangible if the delimiting surfaces that determine that picture were once more of impeccable texture and colour,' Mulder later wrote. Even the possible withdrawal of the RDMZ's grant did not persuade the foundation to change its mind according to Mulder.<sup>23</sup> In 2016 Mulder still recalled a visit to his office by Ida van Zijl and Wim Denslagen. There was further discussion of the rigorous approach, which according to Denslagen did not correspond to what RDMZ was used to. Mulder explained once more that for him the original spatial experience went hand in hand with the restoration of space and surfaces. 'Denslagen disappeared, and that was the end of it'.<sup>24</sup> And so Mulder proceeded to reprise the reconstructive approach he had previously applied to the exterior.

In the photographs taken in the 1970s and '80s, it is obvious that the plasterwork on the upper floor was at that moment painted white [FIG. 3.3/4.14/4.19/4.20]. The only exception was the chimney. The interior had been less frequently repainted than the exterior and significantly fewer different shades emerged when Mulder started to inspect and 'scrape' in search of underlying coats of paint. The greys were less bluish than those he had encountered on the exterior, while the red, blue and yellow were less vivid than on the exterior, especially the yellow, which was 'softer'.<sup>29</sup> On the plasterwork, and also on wooden and metal elements like the window seat in the living area, on cupboards, on the newel post, behind sliding walls, on the floor, on radiators and on the rails of the sliding walls, Mulder found the remains of what was very probably the original paintwork. These traces formed the basis for the new colour scheme in which the colours used to paint the plasterwork were white, yellow, blue and two shades of grey, while the woodwork and radiators were painted in white, black, red, yellow, yellowish green, blue and grey [FIG. 3.8].

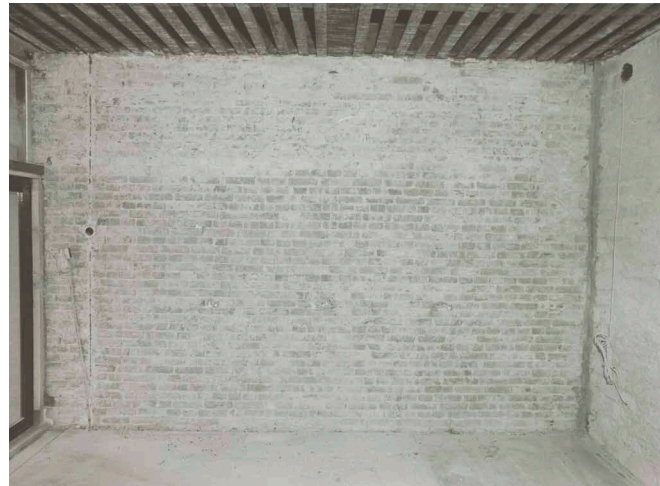
FIG. 3.6 Bare brick wall and stripped ceiling

Before the walls were replastered, the cracks in the brickwork were, like those in the exterior, filled with synthetic mortar. The new metal lath ceiling was suspended from the joists using a (floating) steel network in order to minimize the chance of cracks.<sup>27</sup> The plastering was carried out by the firm of H. van de Kant Afbouwbedrijf Zeist B.V. H. van de Kant recalled that the existing plaster had to be carefully removed and placed in bags in plastic trays, sorted according to wall area and colour. This enabled Mulder to carefully examine the plaster and layers of paint on top of it.<sup>28</sup> After that examination the old plaster was carried away and destroyed. Although the abovementioned memos from 1984 and 1985 refer to a specific plaster mix, Mulder and Van de Kant stated, when asked, that the exact proportions of cement, sand and lime were decided on site. Ultimately, it was the plasterer who determined this, just as in Rietveld's day. After applying the plaster, the plasterers had to sand the base coat 'with jute on a wooden board', to achieve the same effect as under Rietveld. It resulted in a smooth surface with here and there a stray grain of sand, but without any traces of repair work or restoration.

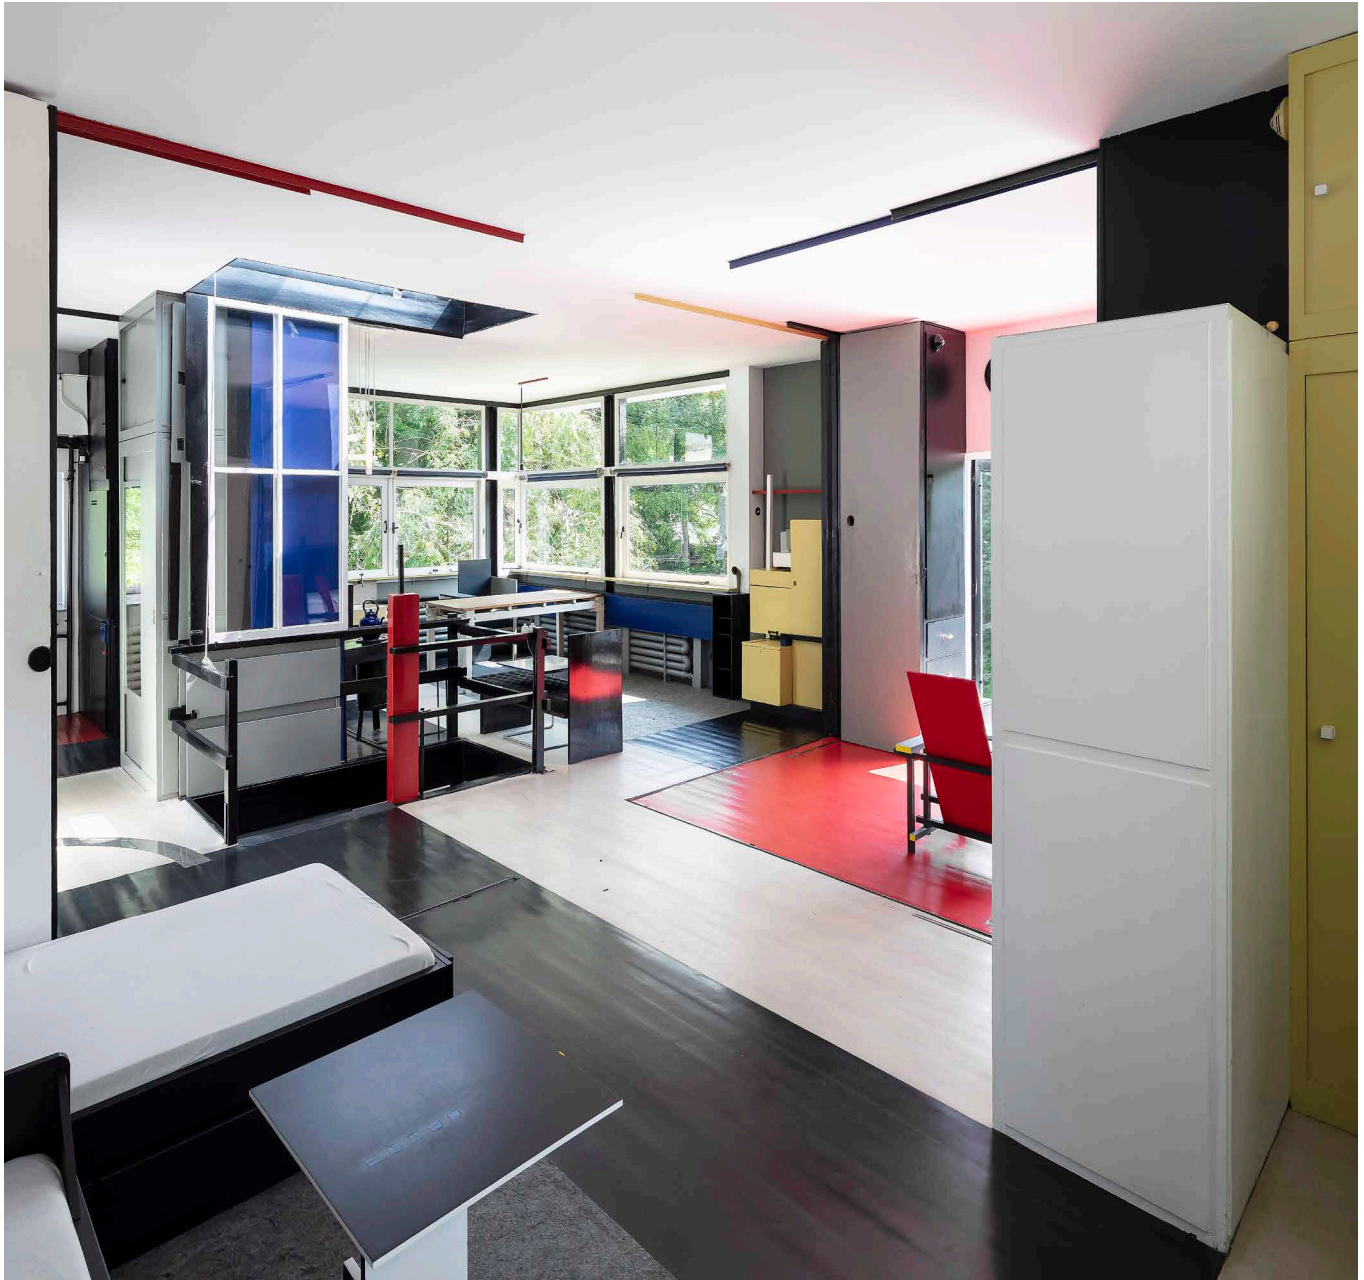
FIG. 3.10 The colour composition of the floor, 2018

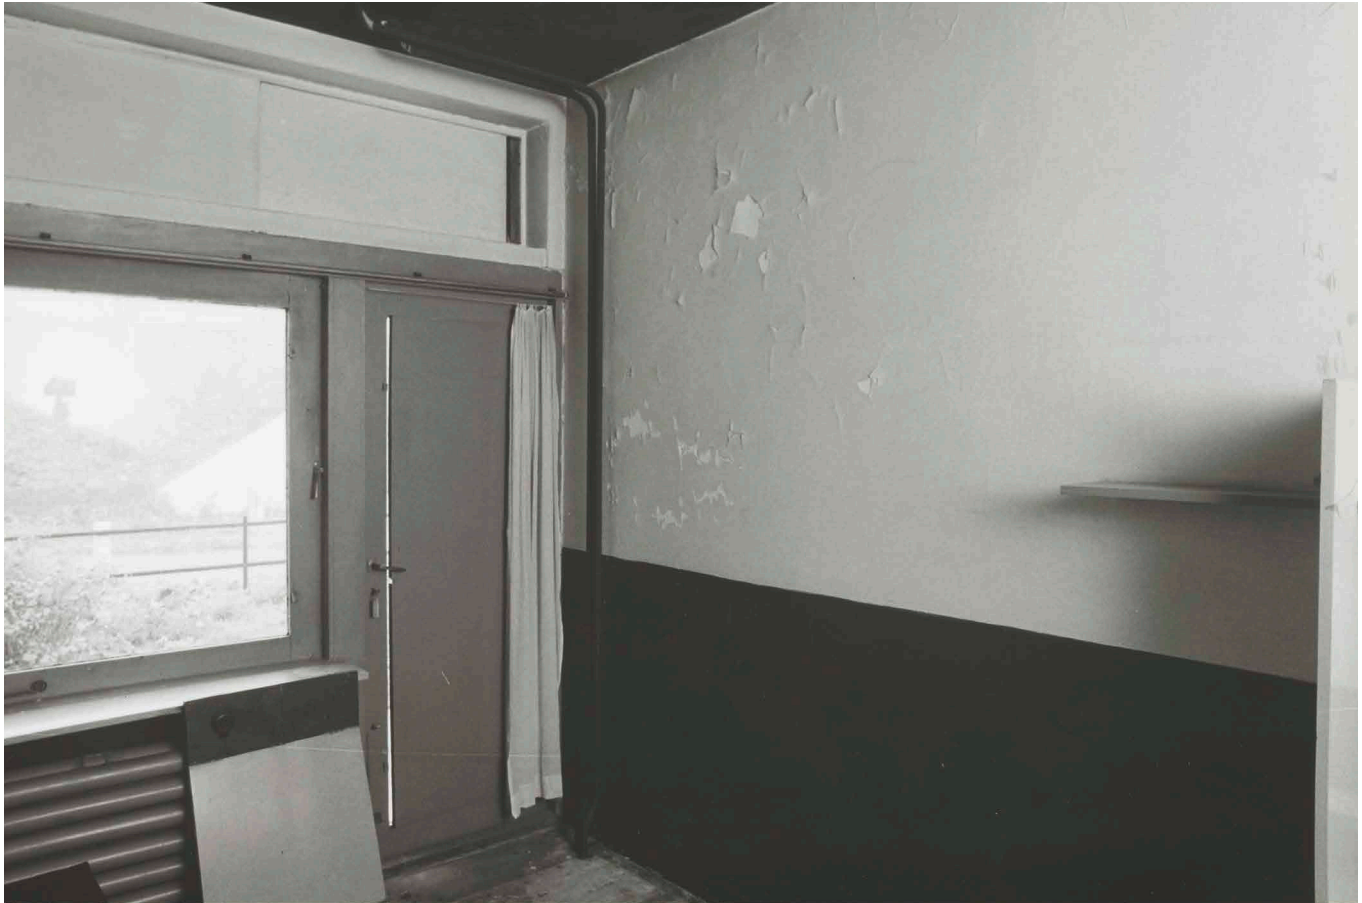
FIG. 3.17 Undated photograph of the study

stripping away the plaster. The colour scheme of the adjoining study, in particular the greys, appeared to have changed little over the course of time, to the extent that this could be established based on historical photographs [FIG. 3.16/3.17]. Mulder recalled that the black ceiling in this room had looked pockmarked and had to be repainted. He had the other surfaces in this room repainted in the existing colours as well.

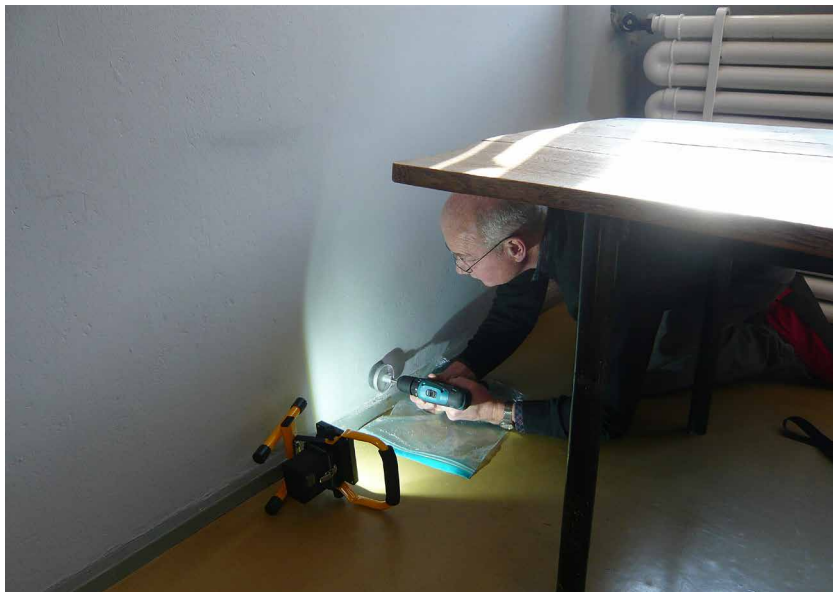
FIG. 3.18 SRAL specialist taking a sample from the east wall of the studio

were asked to analyse the composition of the plaster and finish coats [FIG. 3.18/3.19]. On that occasion samples were also taken of the exterior; these have already been discussed in Chapter 1. Supplementing TNO's conclusions, the SRAL analysis confirmed that there were probably still traces of coloured layers of plaster in several places on the exterior, in two shades of grey. The visual composition and the properties of these layers seem to point in the direction of the stipulations in the Specifications for the Schröder House (1924).<sup>42</sup>

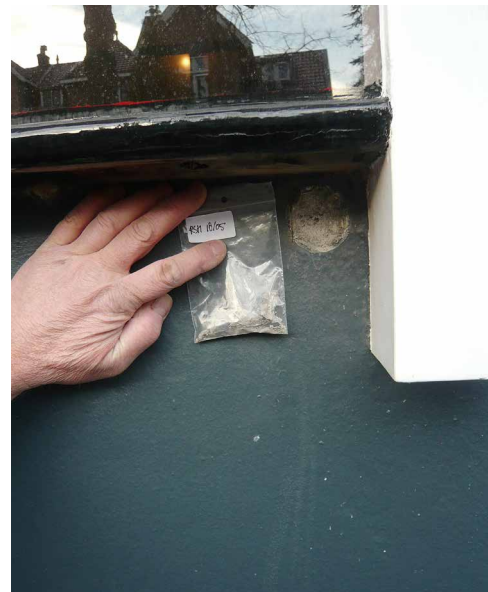
FIG. 3.19 Plaster sample from the wall below the studio window on Prins Hendriklaan

Samples were taken on the ground floor from the south wall of the study and from the east wall of the studio, and on the upper floor from the south wall of the girls' room. These provided insight into the possible differences in composition and finishing of the plasterwork, which turned out to be definitely not (upper floor), and possibly (ground floor) original. The TNO analysis produced one unexpected result: the two plaster samples proved to have the same stratigraphy, which would seem to indicate that both are instances of renovation plaster.

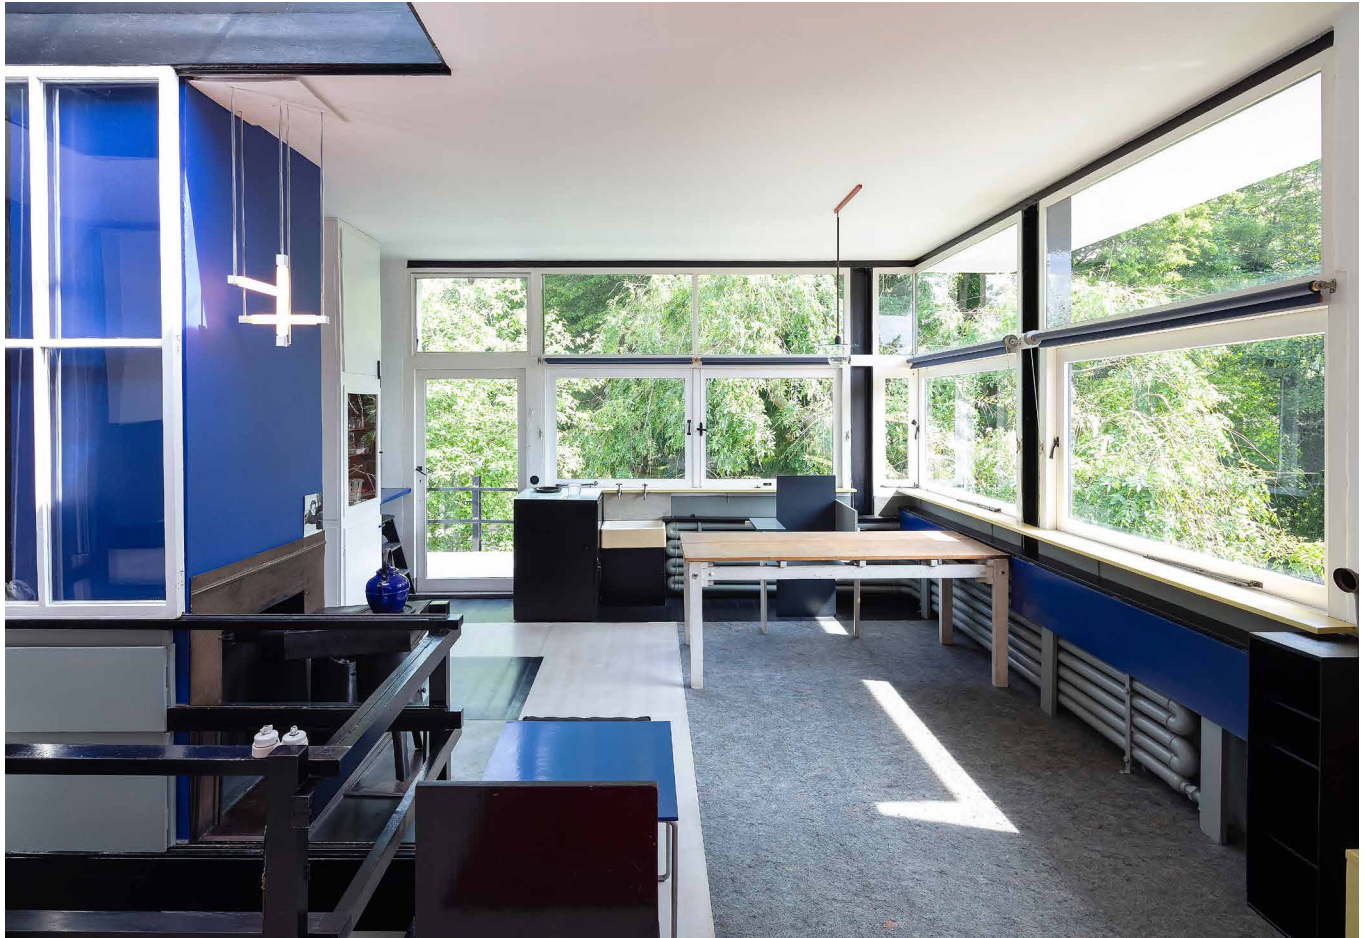
FIG. 4.6 Upper floor interior, dining area, 2018

The original military table, which Schröder had loaned, minus the white rubber top, to the Centraal Museum in 1959 was returned to the house in 1987. A copy of the Berlin chair was placed beside the table. Above it hangs a replica of the original lamp. While the children's stools are no longer there, the desk has been reconstructed, but without the strip lighting and the holes for ink pots [FIG. 4.6].

The original small extendable couch is still there, upholstered in a dark grey fabric.<sup>40</sup> The divan table has been replaced by the side table with blue-painted plywood top and metal base, a design of Gerrit Rietveld from around 1932 [FIG. 4.6].<sup>41</sup> The metal table still stands beside the heater, without the table lamp.<sup>42</sup> The round coal-fired heater stands in front of the chimney and above it hangs a strip light that did not appear in the early series of photographs. On the mantelpiece stands a photo of Gerrit Rietveld. The modular cupboard has been partially reconstructed.<sup>43</sup>

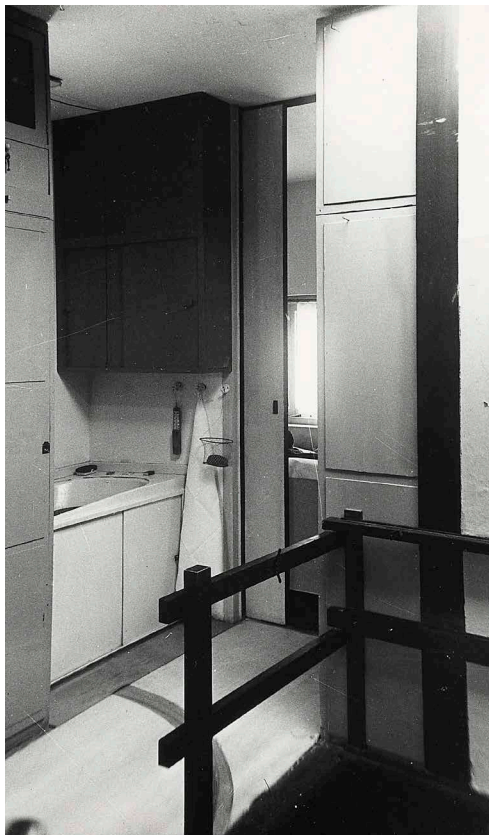
FIG. 4.23 Upper floor interior, bathroom with bathtub, c. 1925

One of the few items Schröder brought with her from her old house on Biltstraat was a bathtub on legs, a typical late nineteenth-century bath. In her new bathroom the bath was concealed behind wooden partitioning and surrounded by cupboards [FIG. 4.23]. The cupboards were in different colours; the partitioning was light-coloured. Against the right-hand wall was a dark-coloured cupboard with four doors, and to the left a tall cupboard.

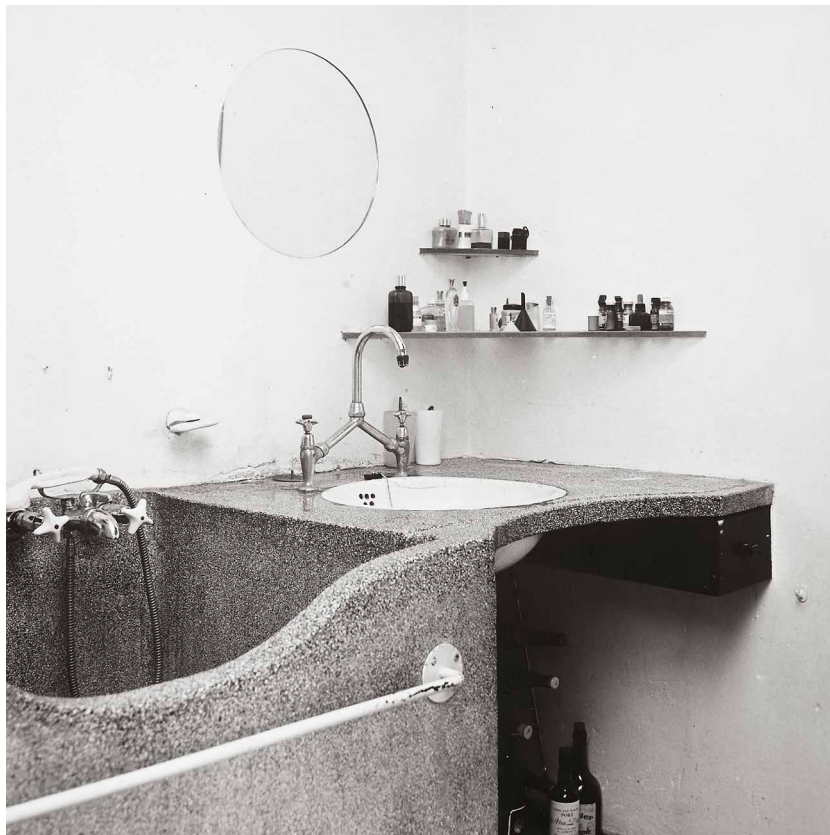
FIG. 4.24 Upper floor interior, bathroom with 'lavette', c. 1936

In the 1930s, Rietveld modified the bathroom. He removed the cupboards on the left and right sides and put in a modern bathroom-cum-laundry sink unit ('lavette') and a granite washbasin [FIG. 4.24]. He made a new storage space below the washbasin. During the war a nearby explosion caused almost all the glass in the house to break, including the thick frosted glass of the letterbox. Rietveld used remnants of this glass to make two shelves in the bathroom with rounded edges echoing the sinuous edges of the sink unit and the washbasin [FIG. 4.24].

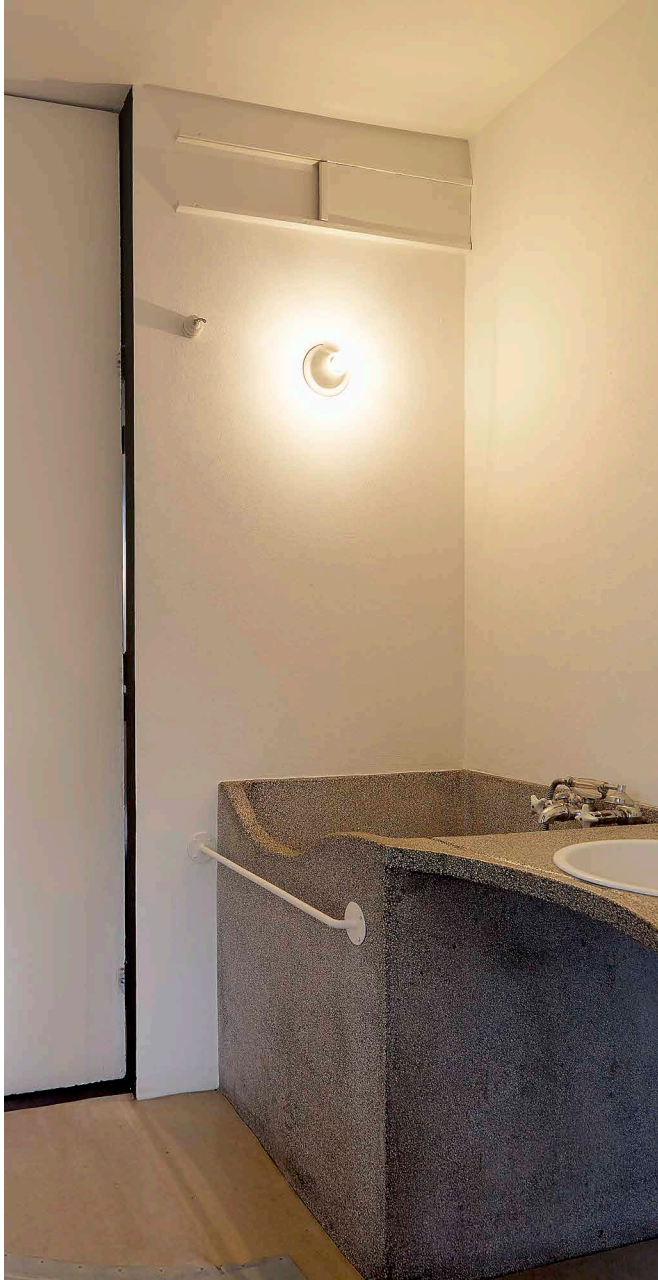
FIG. 4.25 Upper floor interior, bathroom with 'lavette', 2010

In 1982 Han Schröder suggested leaving the bathroom as it was and illustrating the old situation with photographs. It was indeed decided to preserve the 1930s bathroom in the museum house [FIG. 4.25]. Both Mulder and Van Zijl stated that this option was chosen because this bathroom was more of a Rietveld design than the original bathroom. To remove it would be to 'remove Rietveld'. The bathroom was so beautiful that it would have made no sense to remove for the sake of recreating the original situation.<sup>59</sup> According to Mulder the bathroom was not an essential element of the spatial picture and was consequently of less importance. Paul Koster endorsed this view at the time in an article in *De Volkskrant*.<sup>60</sup> The bathroom was self-contained and Koster agreed that the interior designed by Rietveld was much more interesting than the anonymous bathtub.

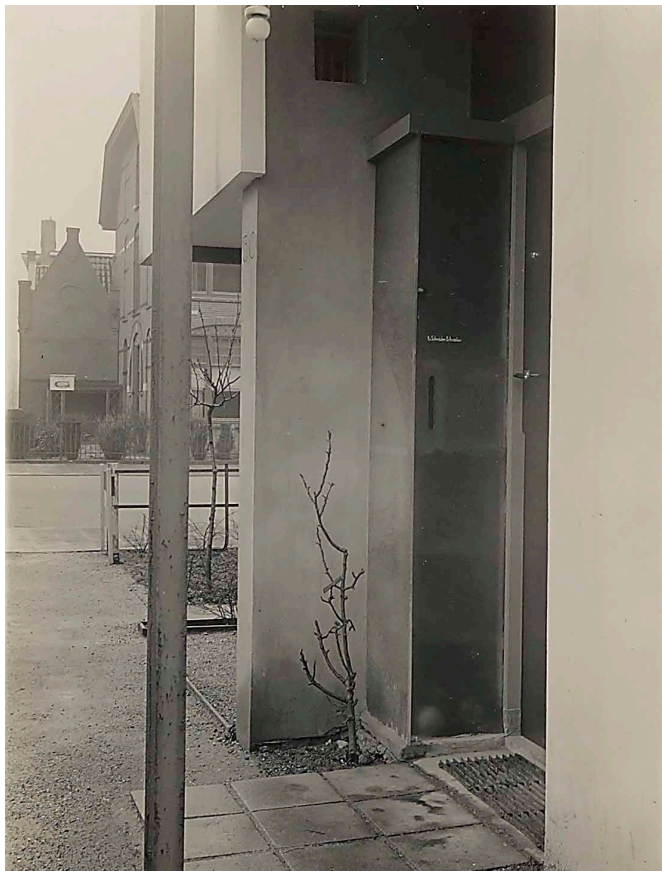
FIG. 4.26 Entrance with lamp and letterbox, c. 1925

Above the entrance hung a simple pear light bulb at the end of a rod [FIG. 4.26]. To the left of the door the number of the house – 50 – was painted in dark numerals.

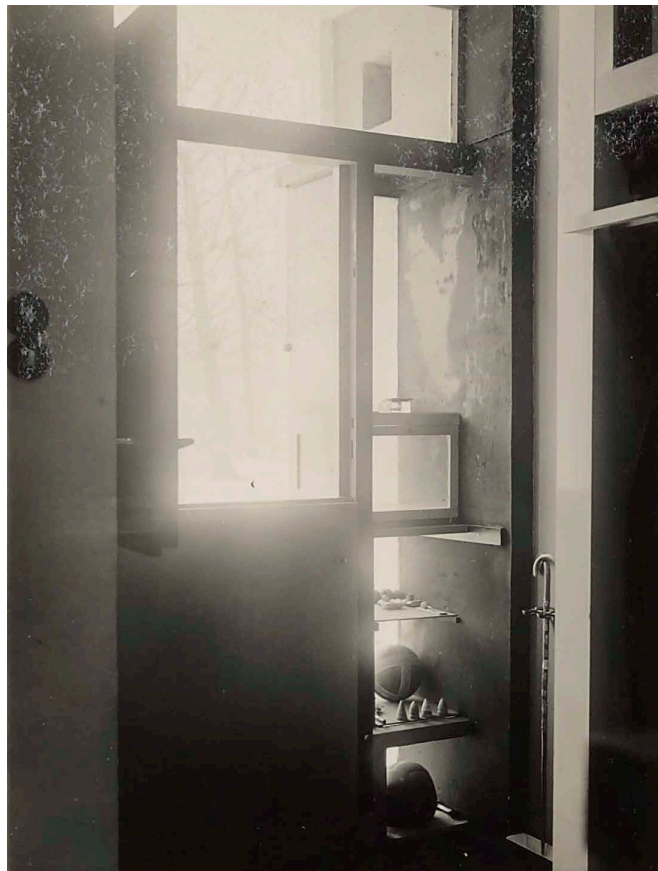
FIG. 4.27 Ground floor, hall with letterbox, c. 1925

The letterbox beside the door was made of glass so that it was possible to see from a distance whether there was any mail [FIG. 4.27]. Above and below the letterbox there was space to put things like outdoor toys.

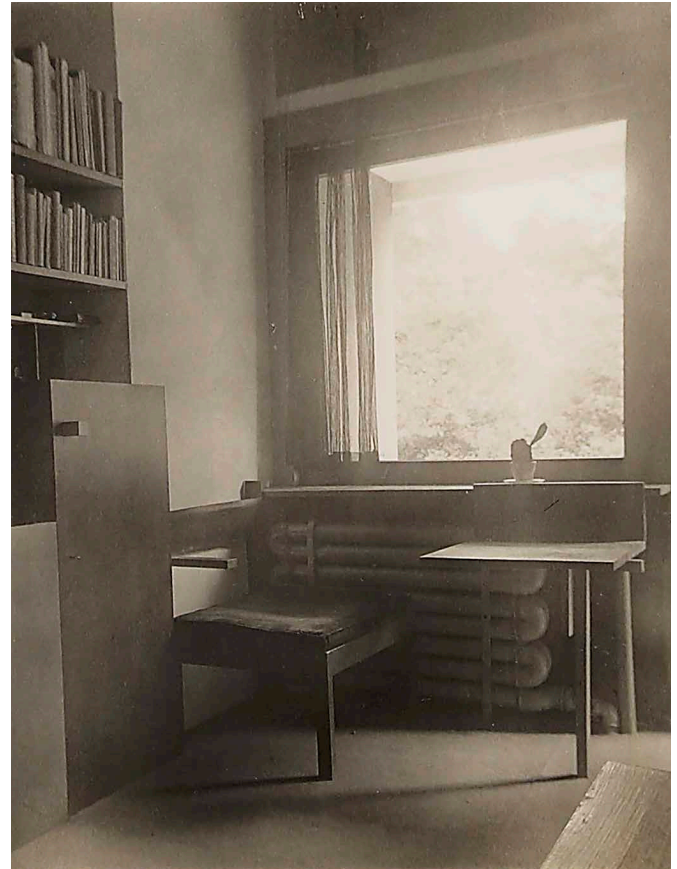
FIG. 4.32 Ground floor, study, c. 1925

Schröder called this room the 'Rietveld room'. She remarked that she considered this the most 'homely' room in the house [FIG. 4.31]. There were coarse black curtains [FIG. 4.32], which look like the curtains in the children's bedrooms [FIG. 4.12]. The space above the window, beneath the balcony was hollow [FIG. 4.32].

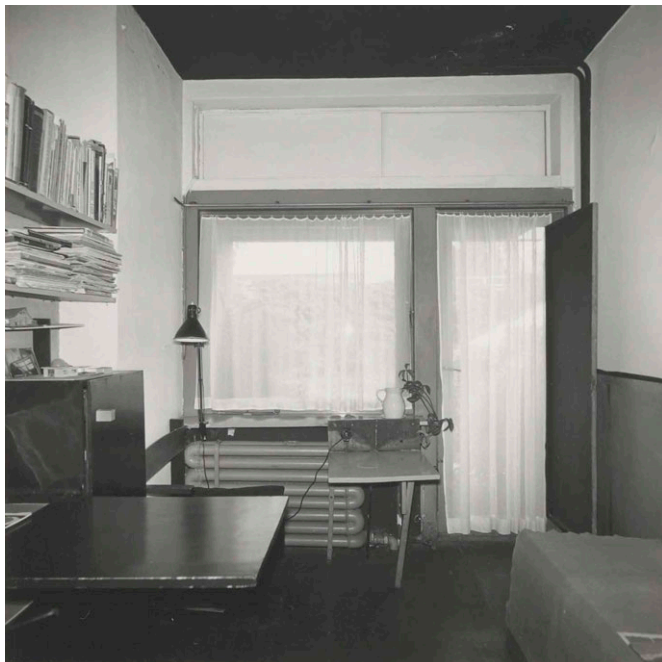
FIG. 4.33 Ground floor, study, c. 1974

Schröder was irritated by the space and quite early on had it closed off with sliding doors [FIG. 4.33].<sup>64</sup> Among the furniture in this room is the piano chair that originally stood behind the piano upstairs. When it started to creak and intrude on the music it was quickly moved downstairs. We also see the armchair, which was specially designed for this room. In another photo this chair stands beside the dining table.
