# COLOUR, FORM AND SPACE

RIETVELD  
SCHRÖDER  
HOUSE  
CHALLENGING  
THE FUTURE

Marie-Thérèse van Thoor [ed.]

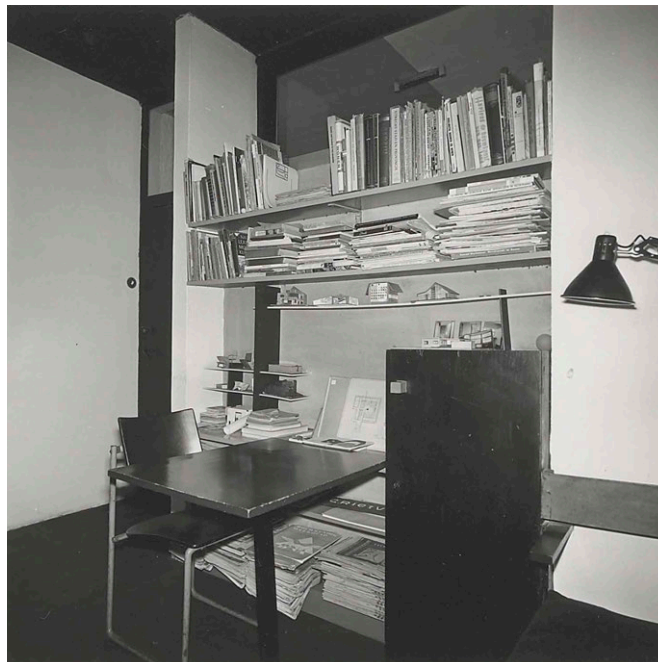
FIG. 4.34 Ground floor, study, c. 1974

The furnishings did not change at all during those years. The shelves became more crowded, chiefly with work by and mementoes of Rietveld. In photographs from 1974 we can see that the shelves are crammed with books and with several architectural and chair models by Rietveld [FIG. 4.34]. Schröder worked on the ground floor organizing the archive.

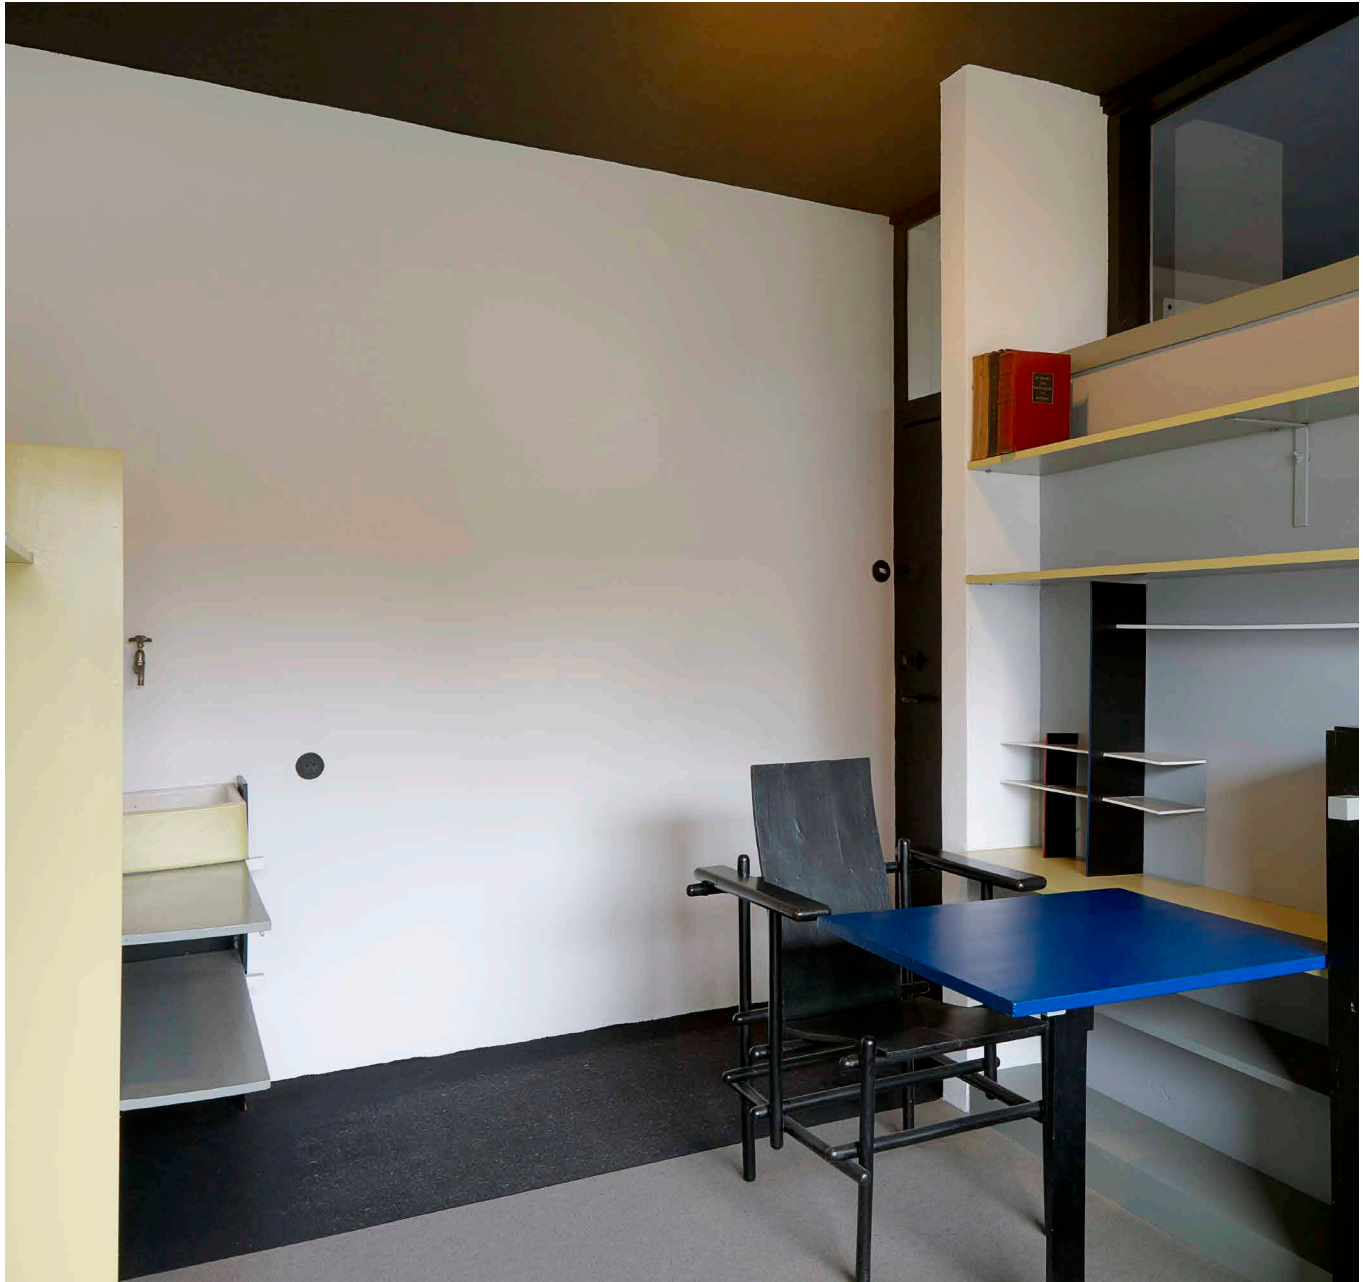
FIG. 4.35 Ground floor, study, c. 2010

When the house was opened as a museum, the red chair with sprung seat stood behind the table.<sup>65</sup> In 2006, it was replaced by the black armchair that originally stood here. The piano chair, which had migrated to the study early on, probably stood there for a long time; it appears in the photos taken in the 1970s. Although the piano chair is part of the Centraal Museum's collection, it has not been in the house since 1987.<sup>66</sup> Han Schröder suggested that the foundation should try to find a piano chair to take its place.<sup>67</sup> A few books have been placed on the shelf to indicate that books had once stood here [FIG. 4.35]. There are no curtains.

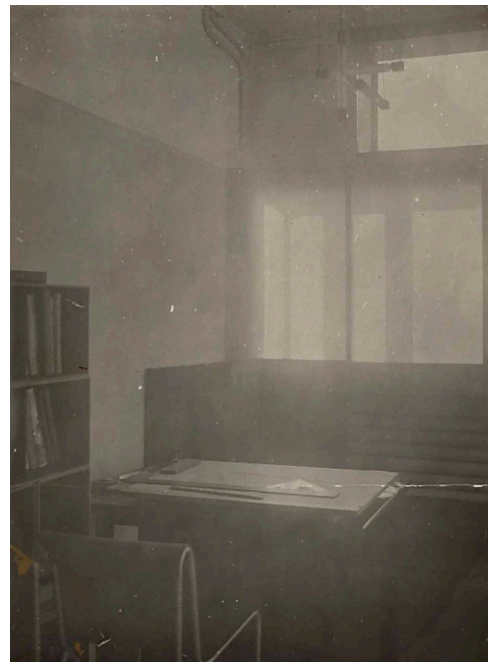
FIG. 4.37 Ground floor, studio, c. 1925

There was a long table on wheels. In a photo of the interior [FIG. 4.37] there are two black rectangles against the wall and the radiator. They cannot be painted surfaces because they overlap the radiator. They could be wooden panels, possibly used to extend the square table. The light-coloured floor covering consisted of diagonally placed *Genemuïden* mats.

The black table stood in this room in 1985 and, like the wooden table, simply remained there. In dimensions and design it looks very like Rietveld's original work table, as seen in an early photo [FIG. 4.37]. It is difficult to determine whether it really is the same table.

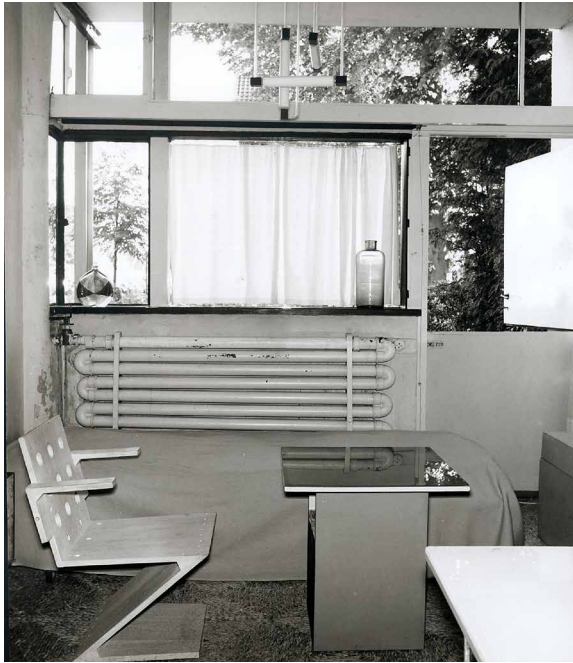
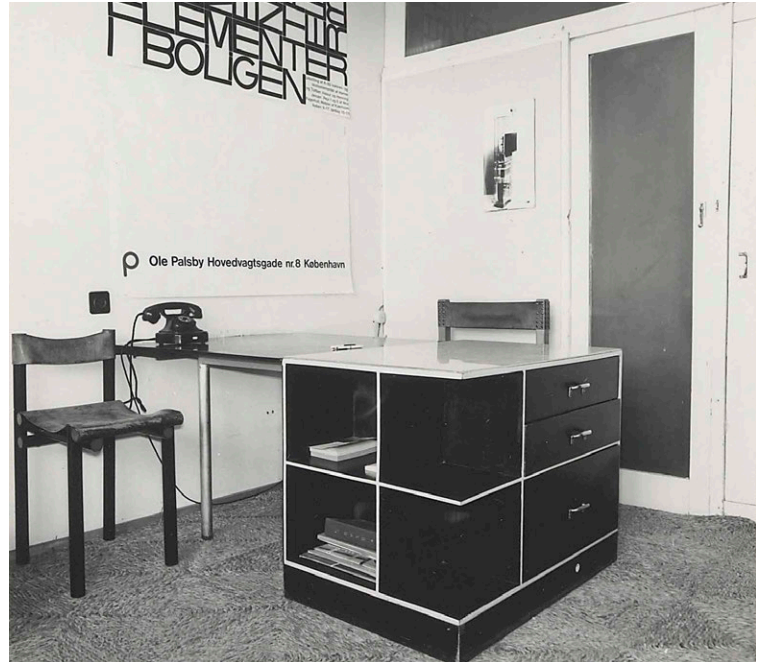
The Genemuiden rugs can be seen in photographs from various periods [FIG. 4.38/4.39] when the room served as a bedroom and study for tenants. A bed stood beside the window, there were curtains and Rietveld furniture: the zigzag chair with holes and arm rests, the piano chair and the upright armchair. Rietveld

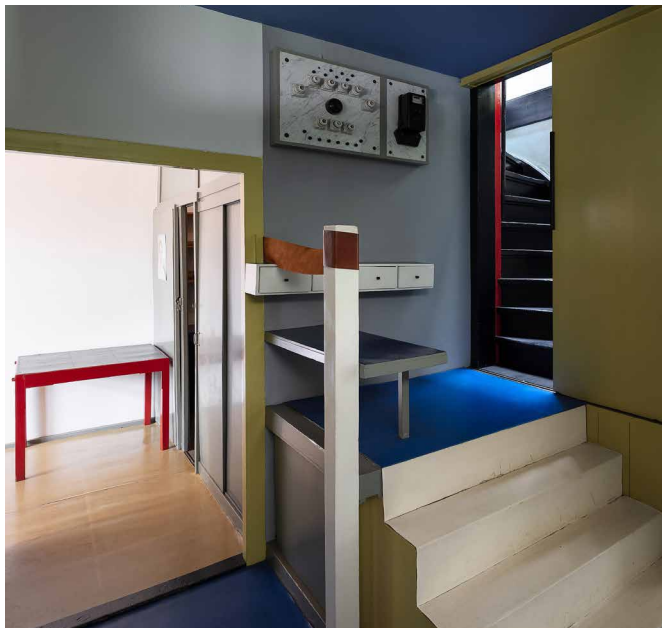
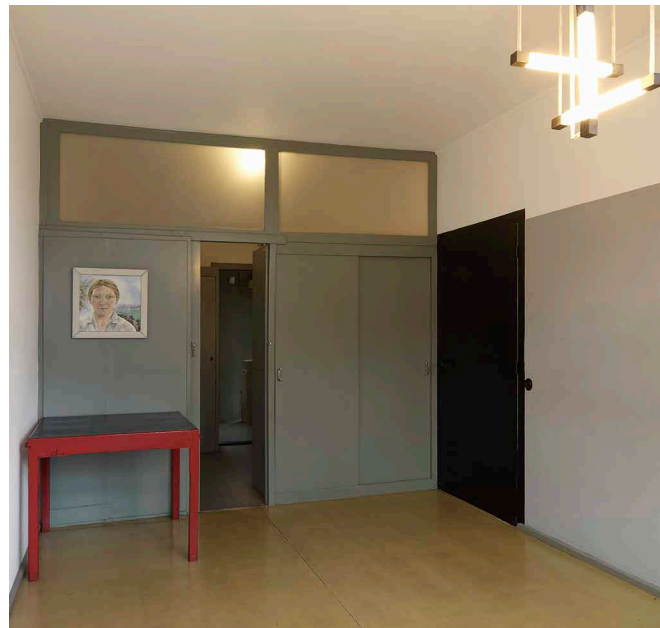
Today the studio is presented with a wooden dining room table [FIG. 3.15] that stood for a long time upstairs in the dining area, together with the zigzag chairs.<sup>73</sup> In the 1980s the table stood in the studio and, according to Ida van Zijl, simply stayed there. The original strip light was still there as was the painting that Elisabeth (Bep) Eskes-Rietveld, Rietveld's daughter, made of Truus Schröder around 1935.<sup>74</sup> There is also a square black table with red base [FIG. 4.40/4.41]. The room is no longer reminiscent of a studio.

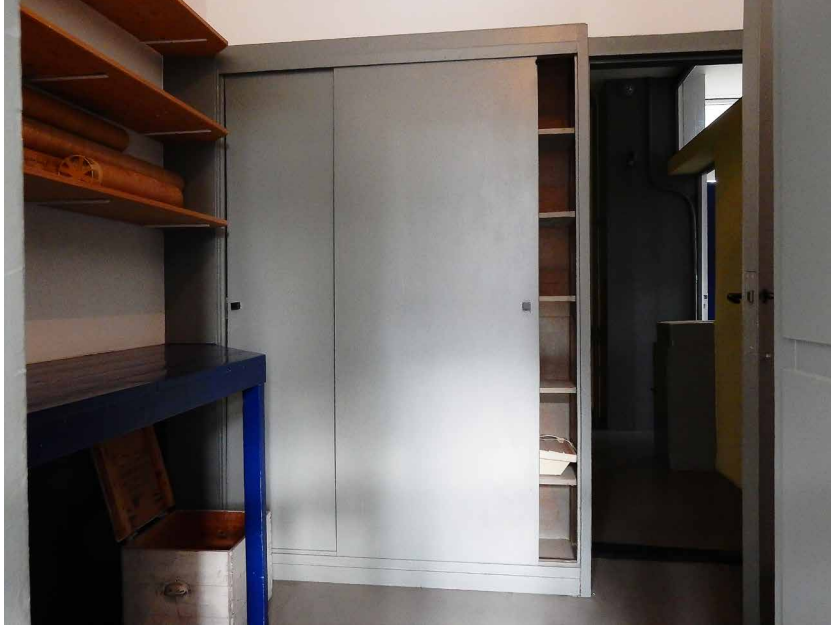
FIG. 4.42 Ground floor, in-between room, 2017

From 1987 onwards this room was presented with a blue workbench and no washbasin [FIG. 4.42]. In the open-fronted cupboards are a few (empty) design drawing cylinders and a typewriter. There is nothing to suggest a darkroom; it is more redolent of a storeroom or archive room.

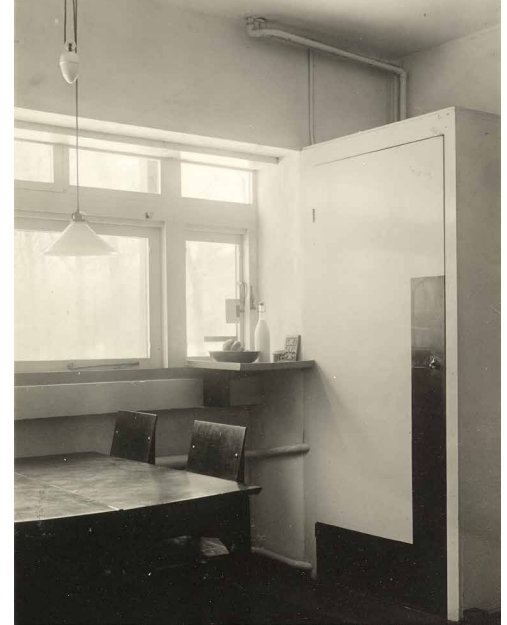
FIG. 4.43 Ground floor, kitchen with deliveries shelf, c. 1925

The most striking thing about this space is the hinged blue deliveries shelf near the window [FIG. 4.43], which was apparently Schröder's idea. Milk and groceries could be handed through the window and placed on the shelf. This was clearly indicated outside on the wall above the window: 'deliveries here' and 'deliveries // ring first, if no answer use speaking tube'.

In the mid 1920s a lamp with a pendulum [FIG. 4.43] hung above the kitchen table. There was also a square red folding table. At least two original military chairs in the colour red were drawn up to the kitchen table [FIG. 4.43]. According to Truus, the worktop was ugly and the sink too deep, but it was a good height. Above the worktop were cupboards with glass sliding doors through which the crockery was visible [FIG. 4.44].

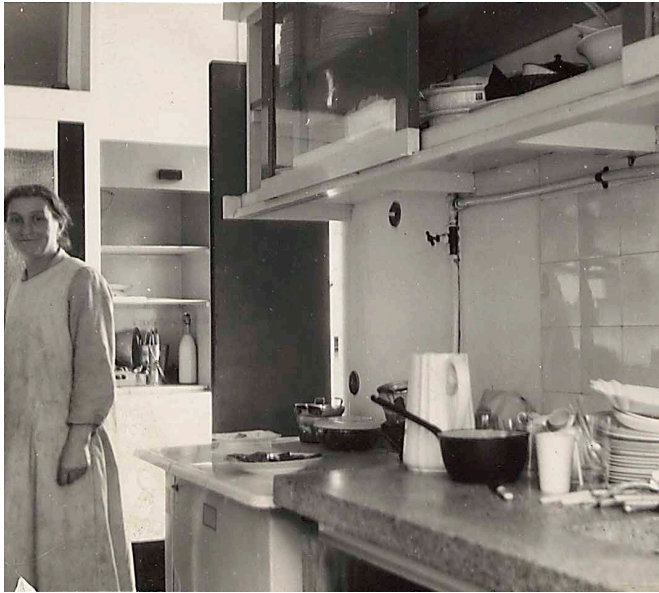
FIG. 4.45 Ground floor, kitchen with daily help, c. 1925

Next to the worktop was a dishwasher [FIG. 4.45], a gift from the director of Pegasus, the Utrecht electricity company. Installing such a modern machine in this very modern house was good publicity for the company. There was a free-standing stove [FIG. 4.46] and above it a rack for pots and pans.

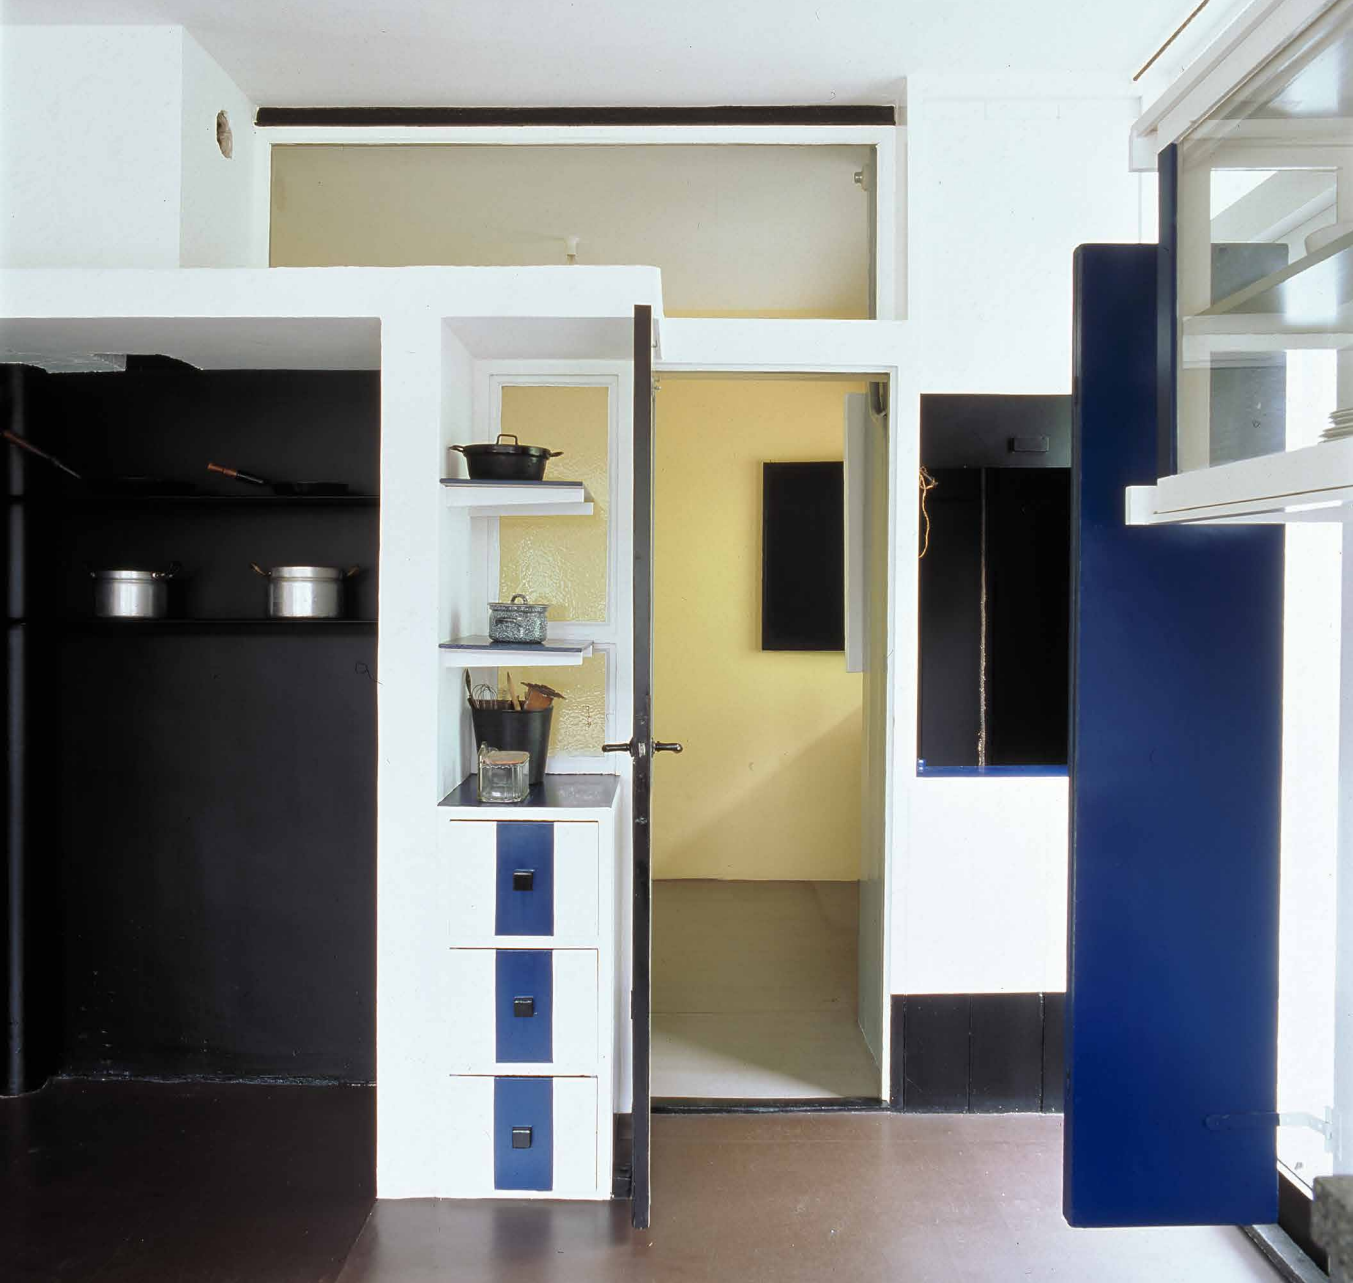
FIG. 4.48 Ground floor, kitchen, 2005

Crockery and pots and pans were placed in the cupboard to illustrate its function [FIG. 4.48/4.49].

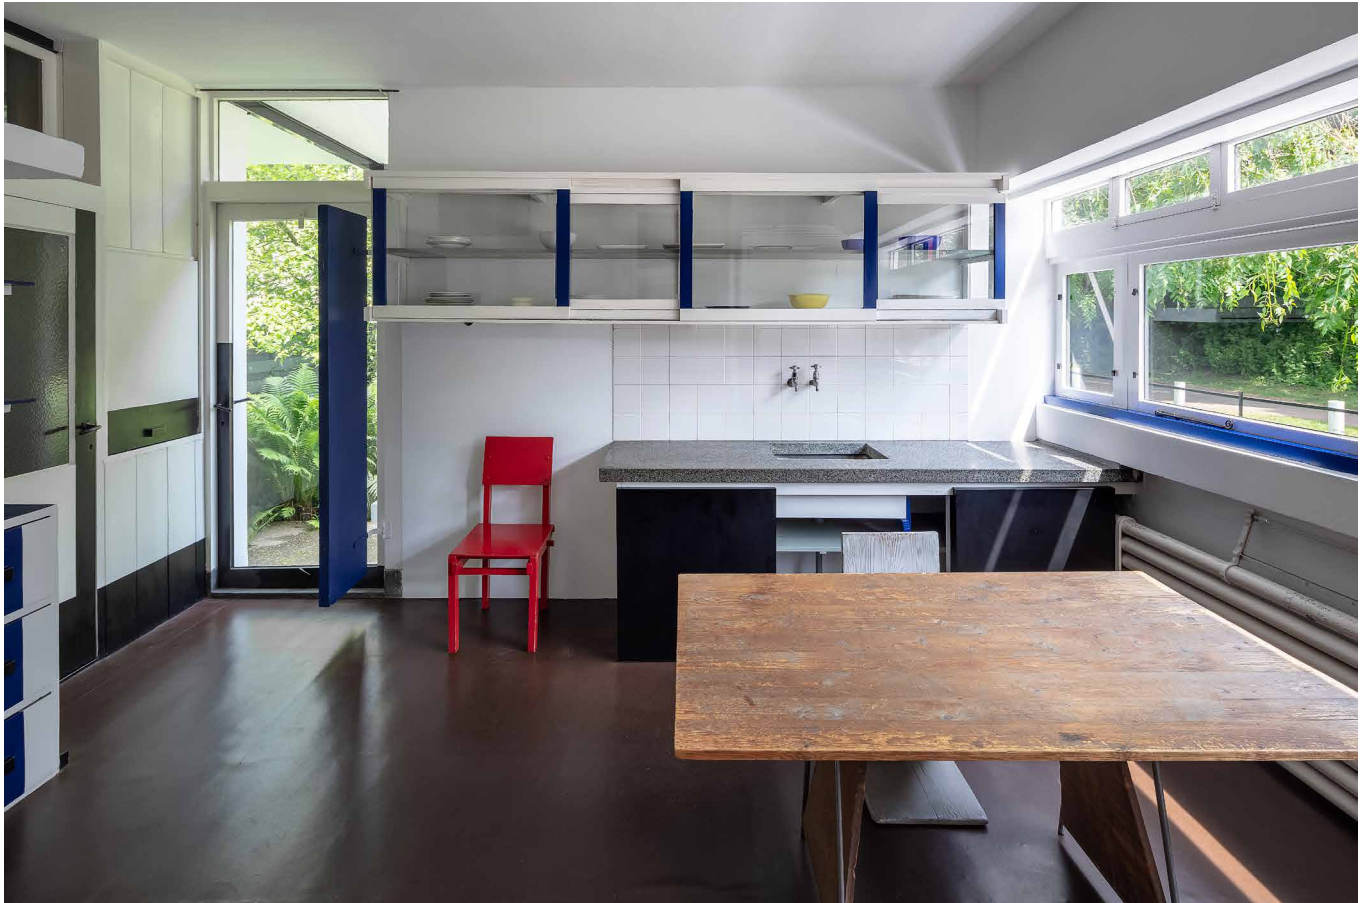
FIG. 4.49 Ground floor, kitchen, 2018

The kitchen worktop and the glass-fronted cupboard were reconstructed, but the two shelves to the right of the cupboard were not [FIG. 4.49].

There are now zigzag chairs drawn up to the table [FIG. 4.49].<sup>79</sup> In 1987, two earlier zigzag chairs from upstairs were placed in the kitchen. In 2006, one of these chairs was removed and is now frequently on display in the Centraal Museum. One of the military chairs stands in the kitchen, against the wall where the dishwasher previously stood [FIG. 4.49].<sup>80</sup>

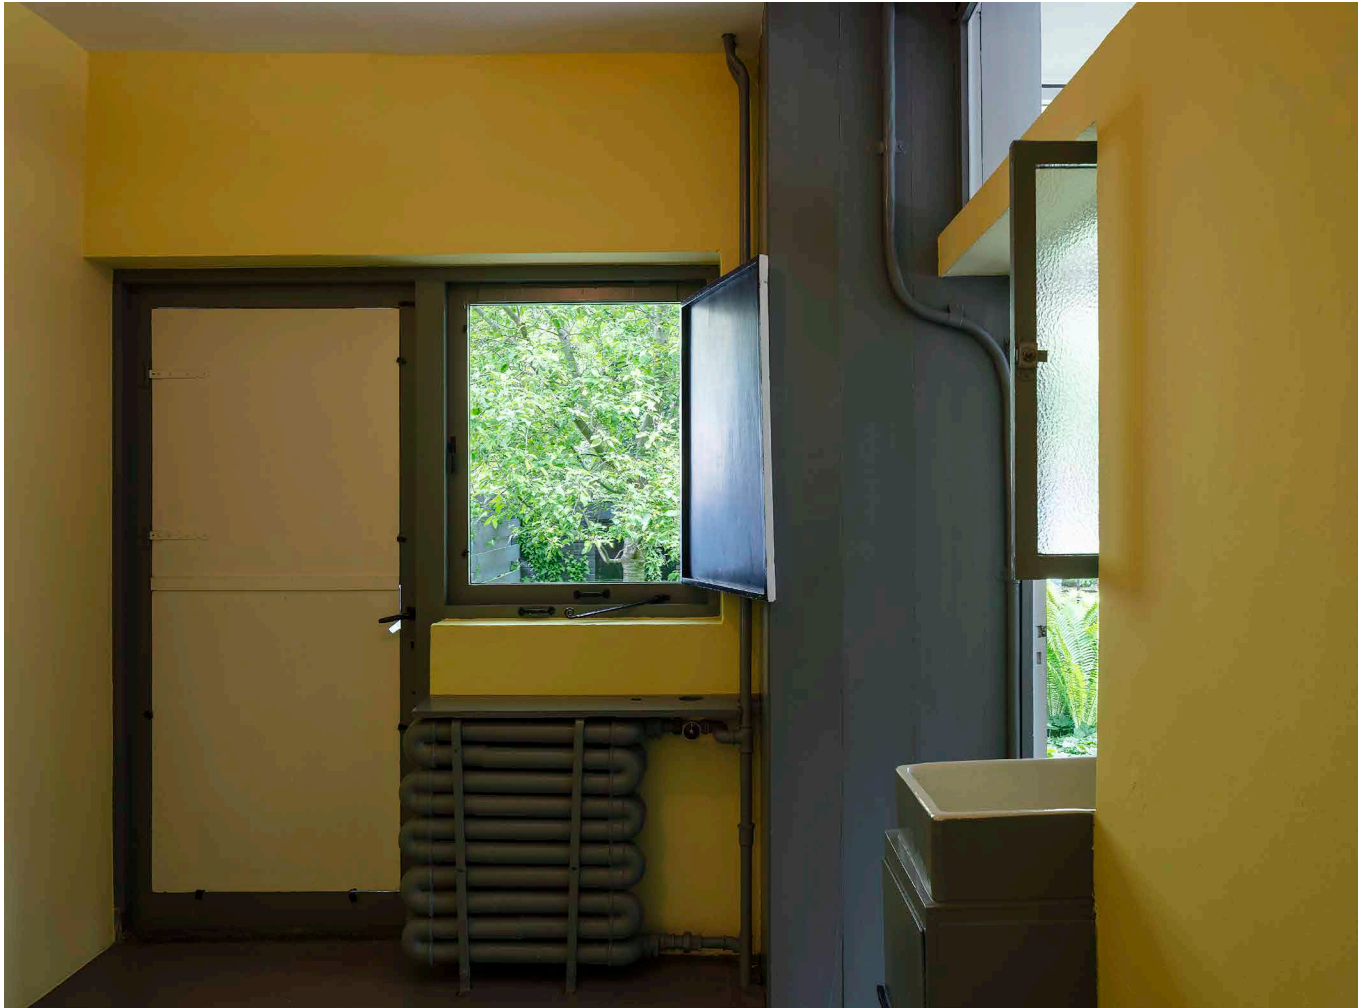
FIG. 4.50 Ground floor, room for the help, 2018

'There were always curtains in this room, green and open-weave,' Schröder recalled.<sup>81</sup> Later, shelves were installed. Perhaps Schröder meant shutters? Or the grey shelf above the radiator [FIG. 4.50]? The floor was yellow but Schröder did not say what kind of material it was.

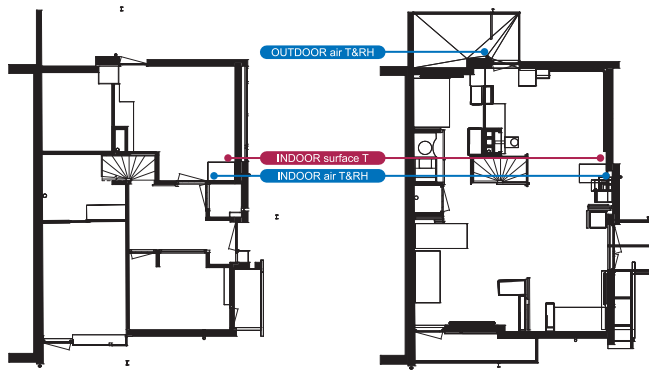
FIG. 5.1 Location of the sensors on the ground (left) and 1<sup>st</sup> (right) floor.

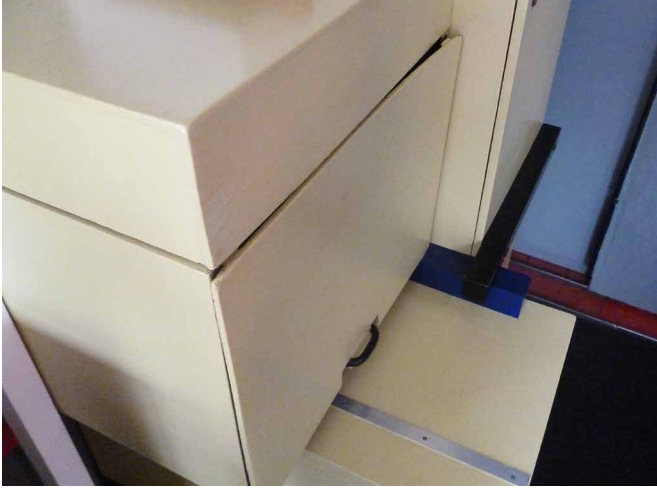
FIG. 5.2 Deformation of thin timber elements of furniture

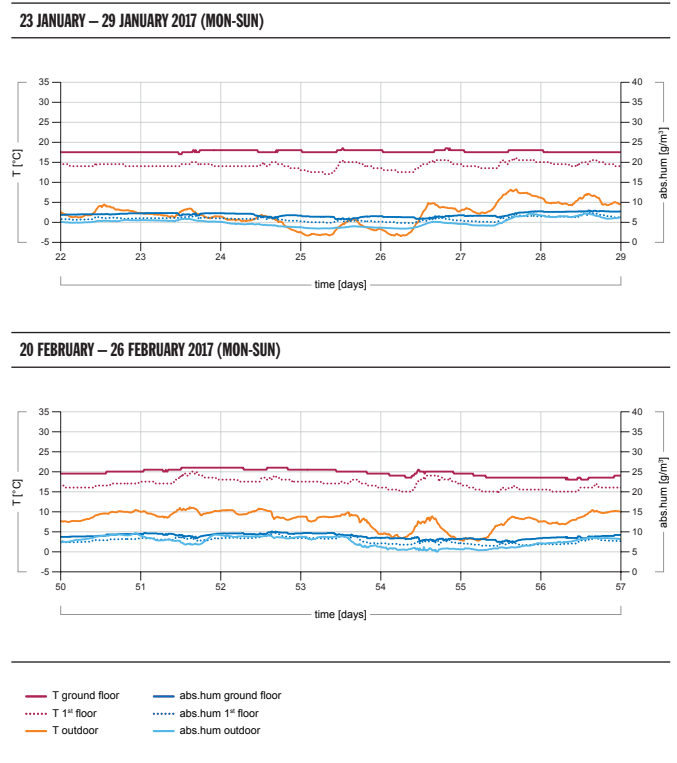
FIG. 5.6 Indoor and outdoor T and absolute humidity on ground and 1<sup>st</sup> floor during two weeks in the winter period

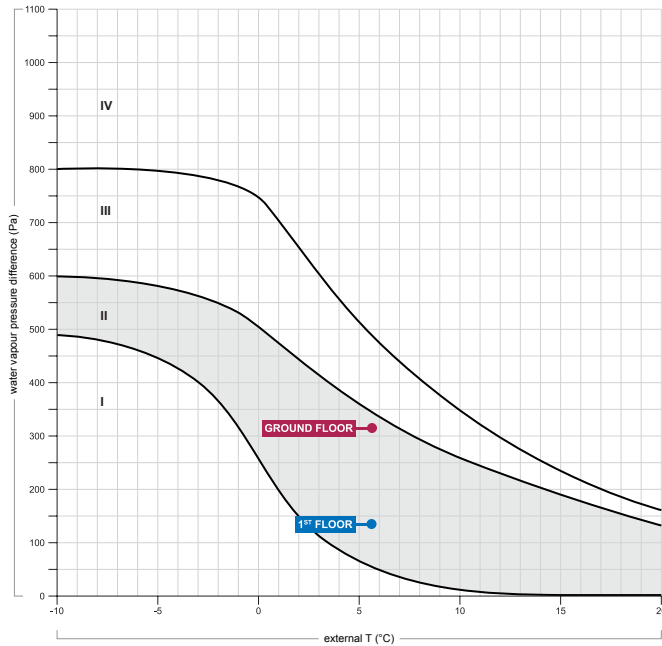
FIG. 5.7 The indoor climate class on the ground and first floors of the building (the period between 20/01/17 and 20/03/2017 was considered)

First of all, in order to assess the risk of surface condensation and/or mould growth, the indoor climate is compared to the classes of indoor climate as defined in Van Hees (1986);<sup>7</sup> the ground floor is more humid than the first floor, but both fall within climate class II, which means that the indoor climate is sufficiently dry [FIG. 5.7]. Therefore, in principle (under the current regime) no moisture problems in the sense of surface condensation or mould growth on the building construction are to be expected.

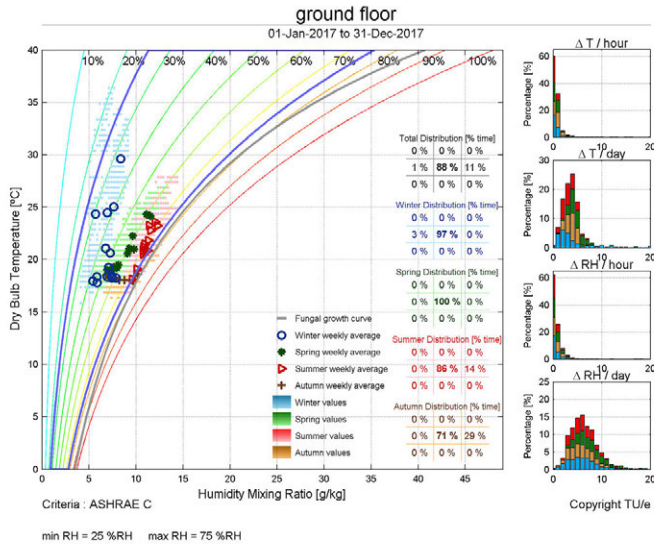
FIG. 5.8 Temperature and RH data recorded on the ground floor of the building in 2017 compared to the specifications for class C; graphical elaboration performed using the web tool available at <http://www.monumenten.bwk.tue.nl/>

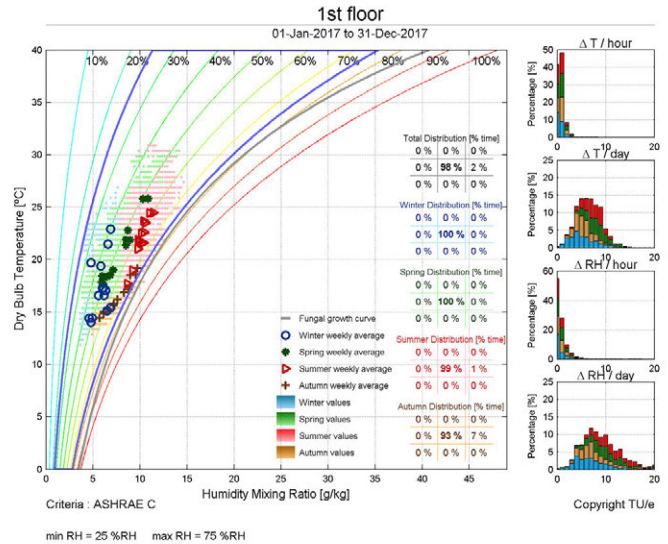
FIG. 5.9 Temperature and RH data recorded on the first floor of the building in 2017 compared to the specifications for class C; graphical elaboration performed using the web tool available at <http://www.monumenten.bwk.tue.nl/>
